NATIONAL ASSOCIATION OF ABANDONED MINED LANDS

Nomination Category: Environmental Contamination and Physical Hazard

Project Name: Fairday Mine Reclamation Project
Project Location: Boulder County, Colorado

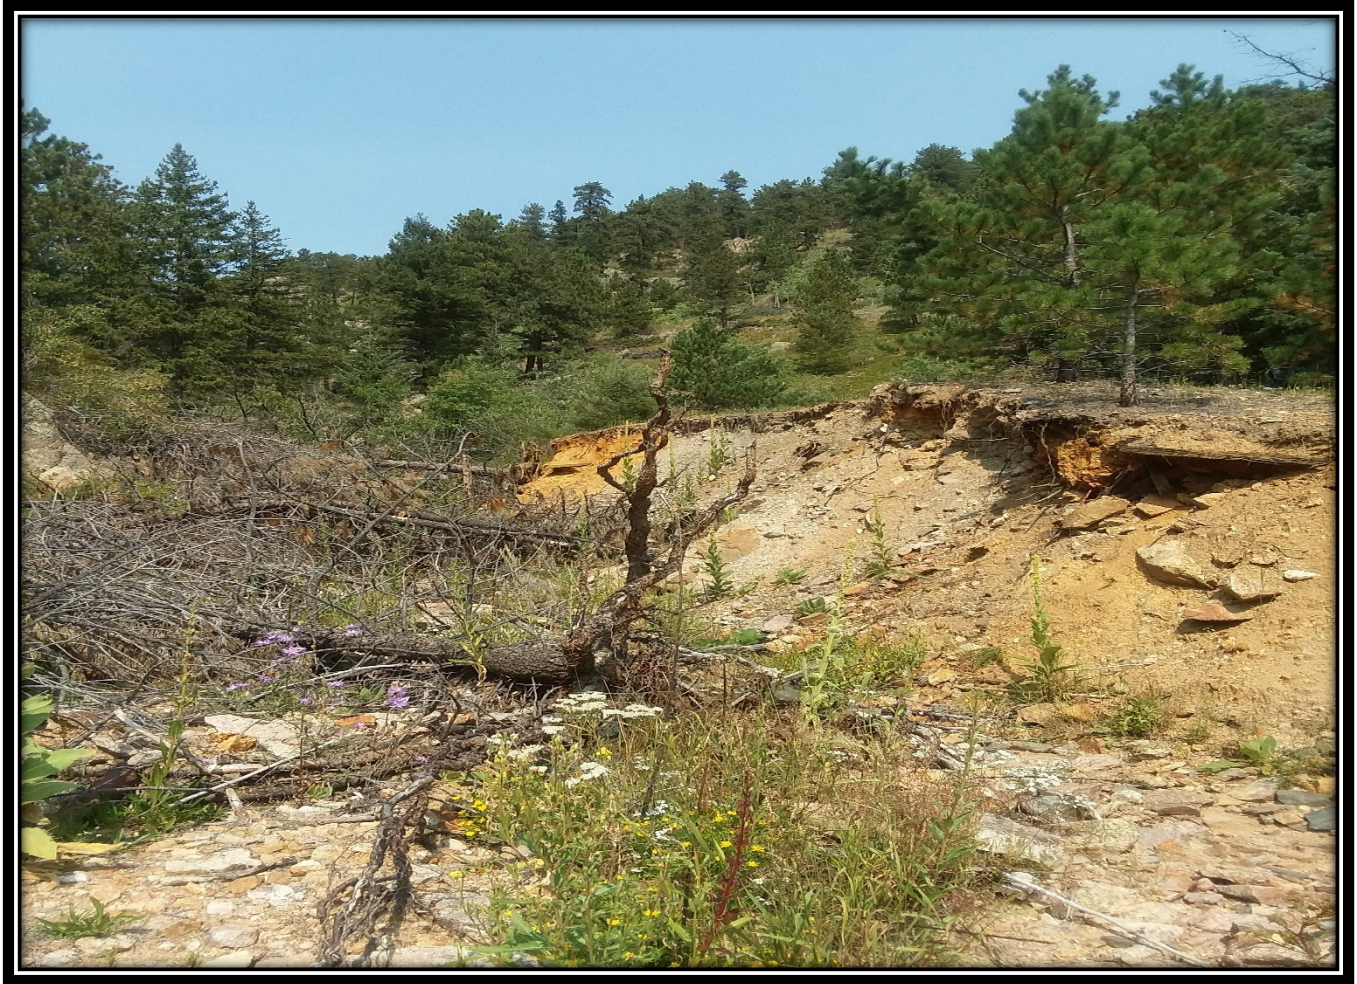
Prior to reclamation, surface flow in the unnamed tributary to James Creek continually came in contact with waste rock and tailings from the damaged Fairday repository and the new cut bank slopes. **Sediment containing uranium, vanadium, thallium, strontium, arsenic, mercury and lead was continuously eroded into the tributary.** The tributary merges with James Creek about 0.25 mile downstream of the mine, and about 1.5 miles upstream of Jamestown. The intake for the Jamestown water supply is on James Creek, downstream from the mine site.

Photo #1-Cut Bank Slopes containing Radioactive Metal- Laden Waste Rock/Wooden Debris Deposited by Flood Pre-Reclamation

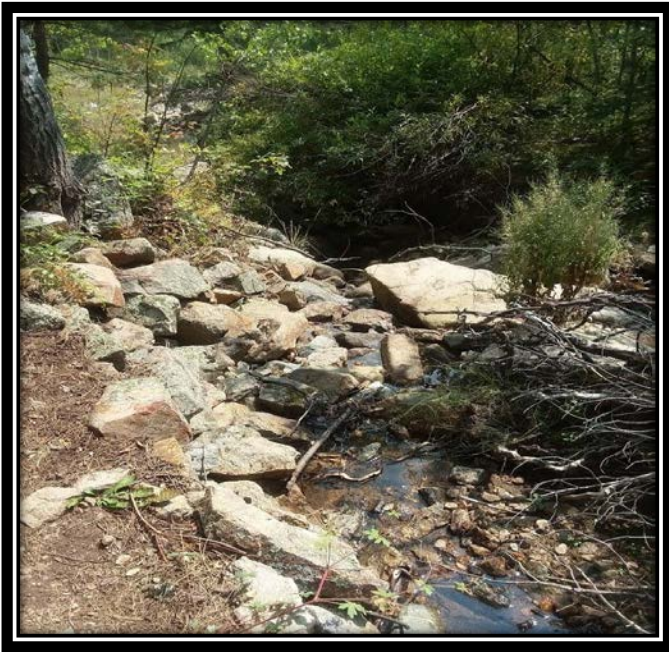
Photo #2 – Mine Access Road Prior to Construction

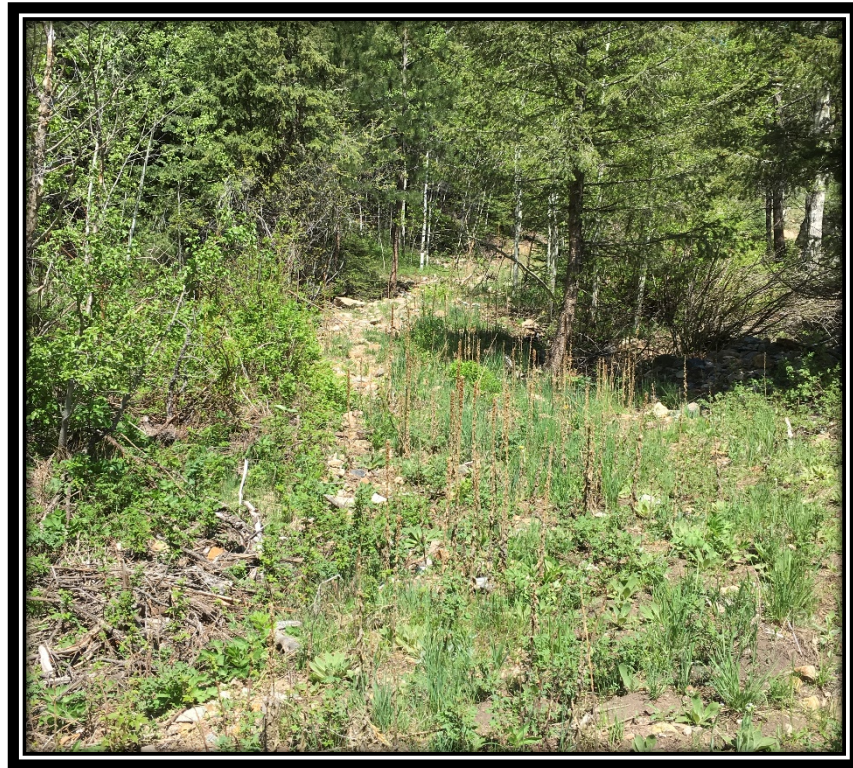
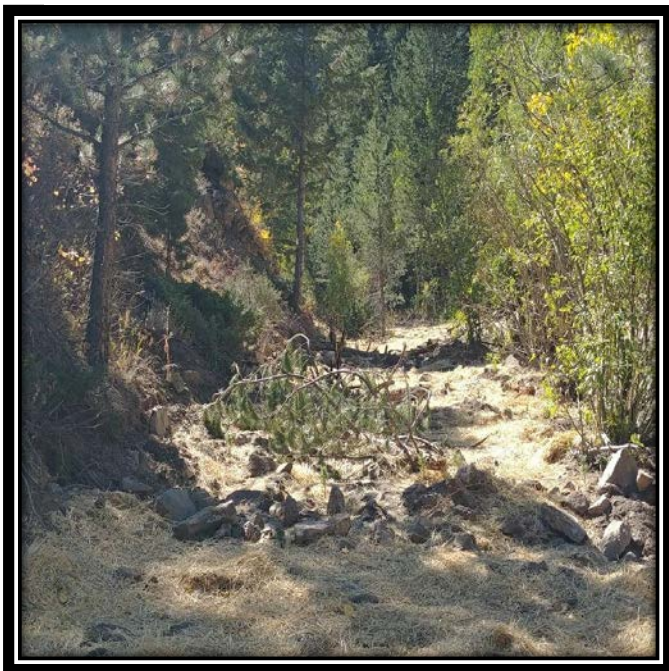
Photos #3 and #4- Reclaimed Mine Site Access Road

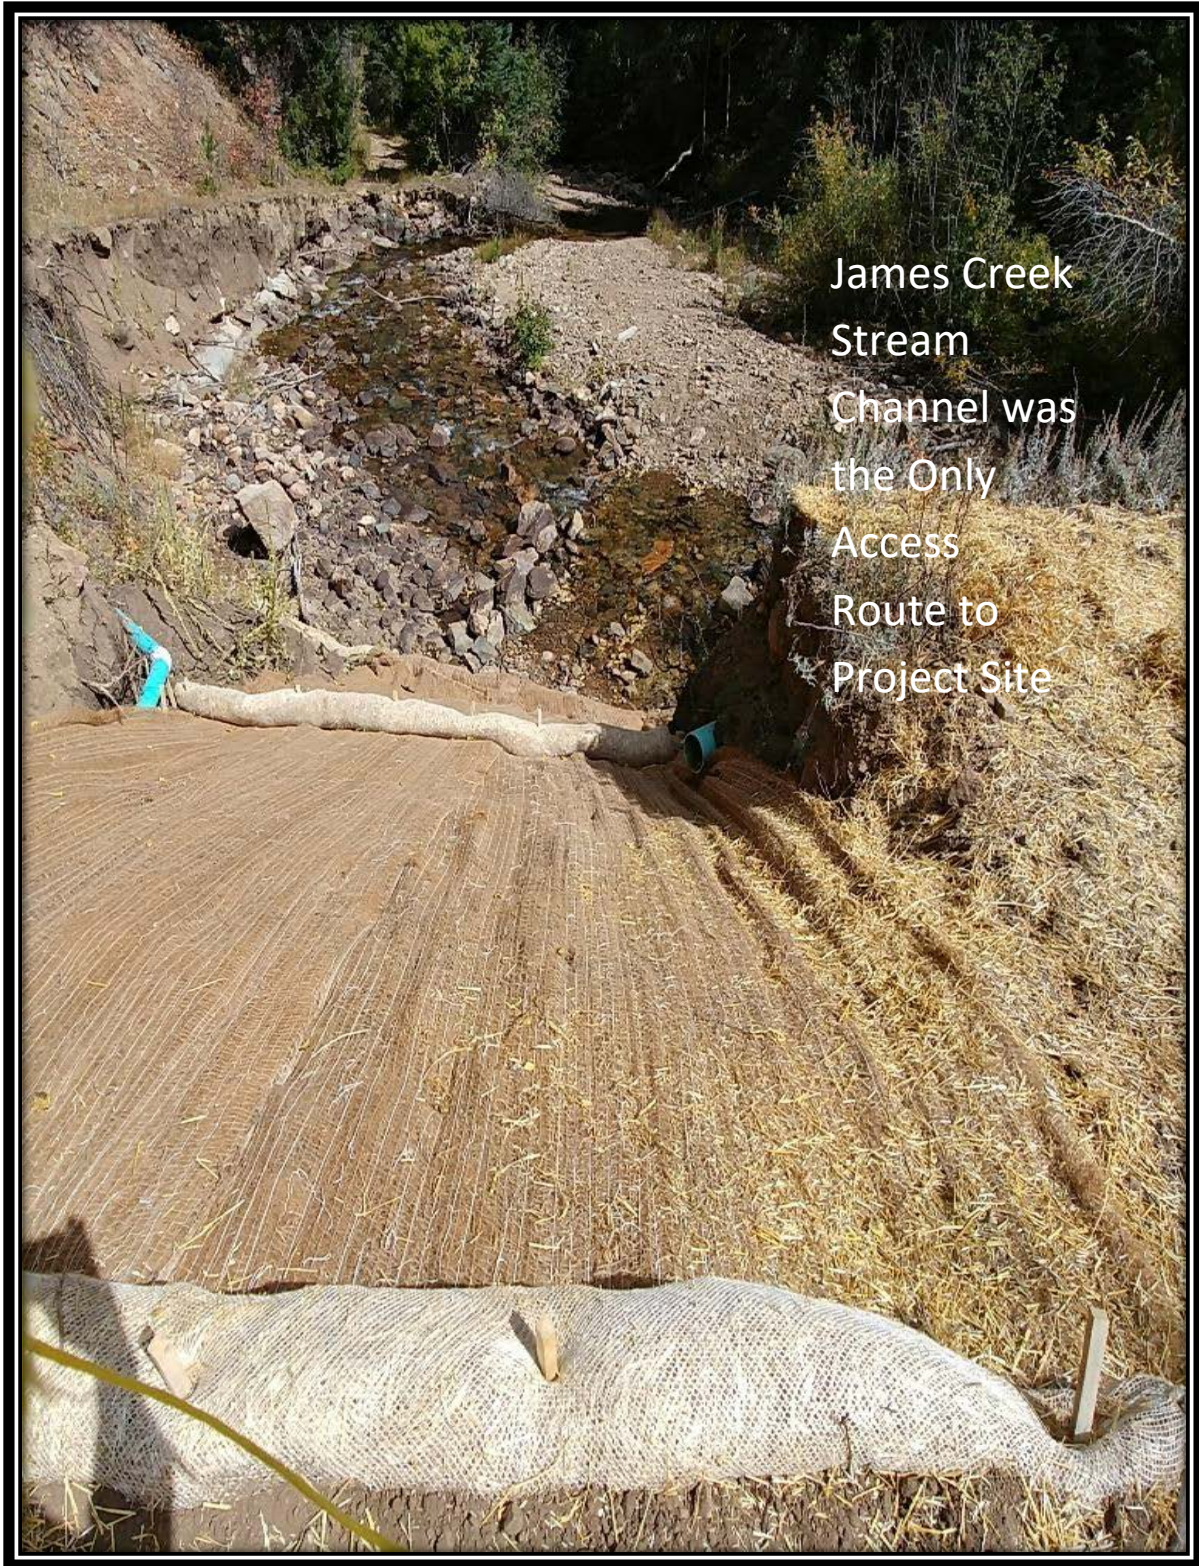
James Creek
Stream
Channel was
the Only
Access
Route to
Project Site

Photo #5 - Reclaimed Access Ramp into James Creek (The Remains of the County Road can be Seen in the Upper Left Part of the Photo)

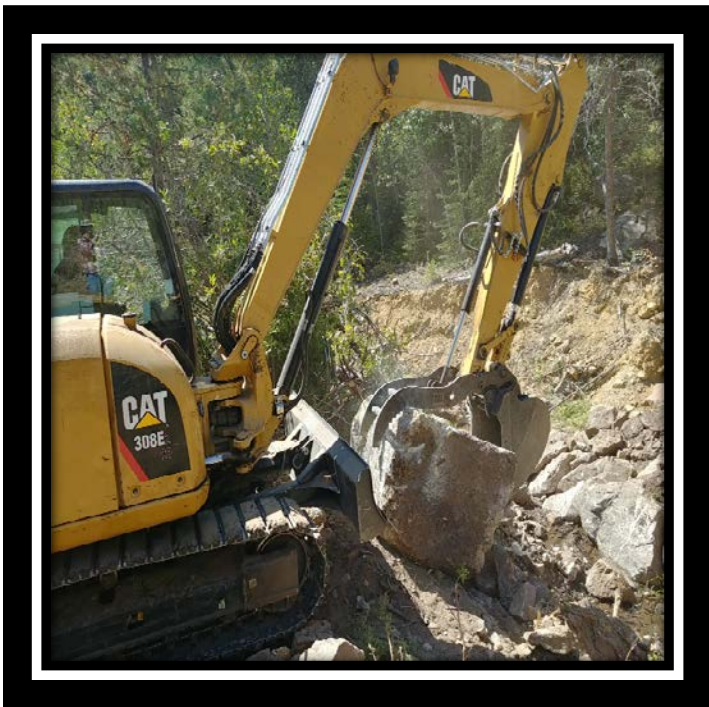
Photo # 6-Armoring the Channel with Riprap

Following removal of the waste rock, the lower portions of the slopes abutting the channel were covered with geotextile, topsoil and armored with rip rap. Several courses of rip rap were placed below the bed of the channel adjacent to the streambank to prevent undercutting of the armored slopes during storm events. Drop structures and stilling basins were constructed to slow the flow of water in the channel and catch sediment. Obtaining the necessary amount of large rip rap to complete the project was very challenging. There was a limited quantity of suitable material in the near vicinity of the project site and the skid steer did not have the capacity to transport large rip rap. Consequently, the excavator had to travel over 1/2 mile in some cases to obtain the necessary material.

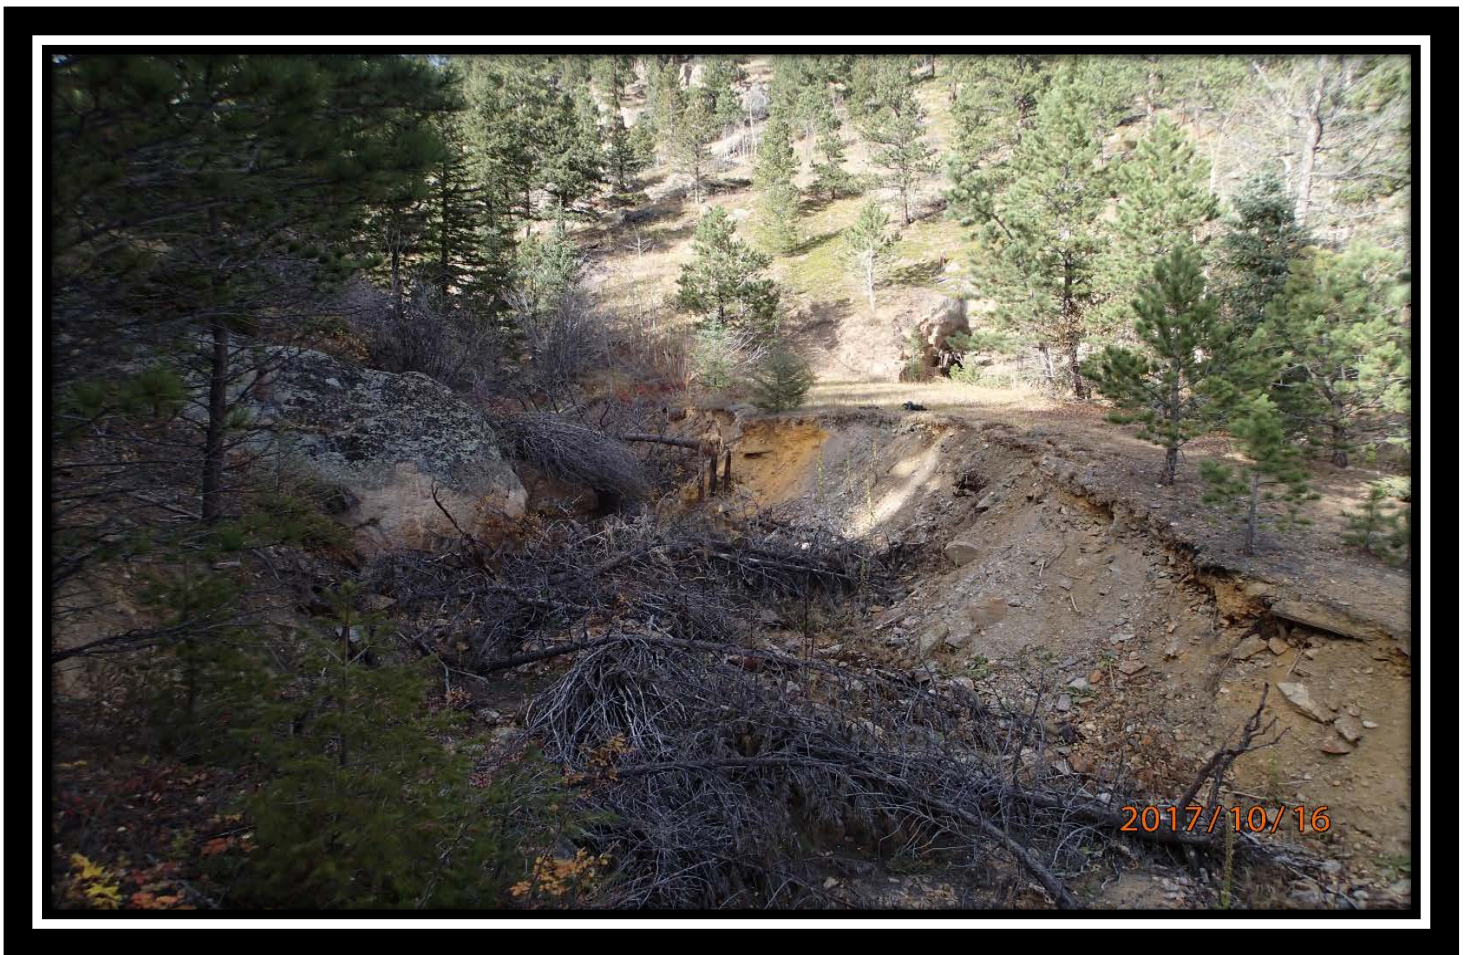
Photo #8 - Cut Bank Slopes- Exposed Tailings and Mine Waste (Pre-Reclamation)

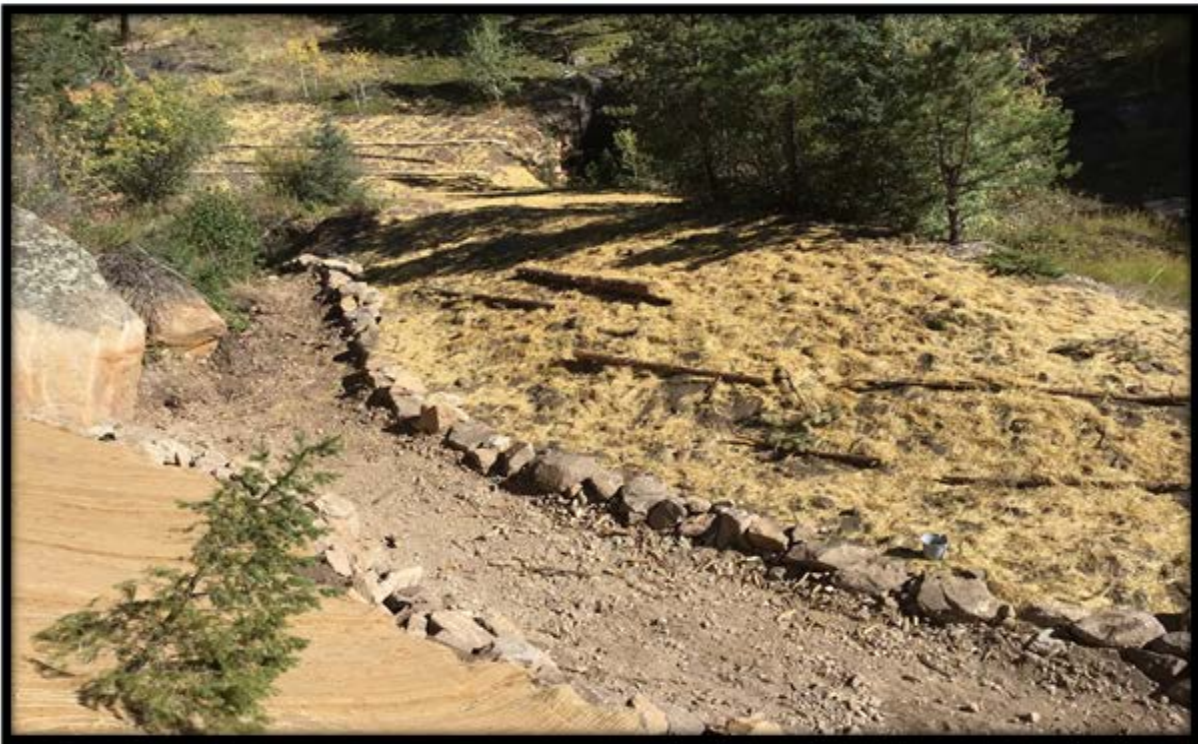
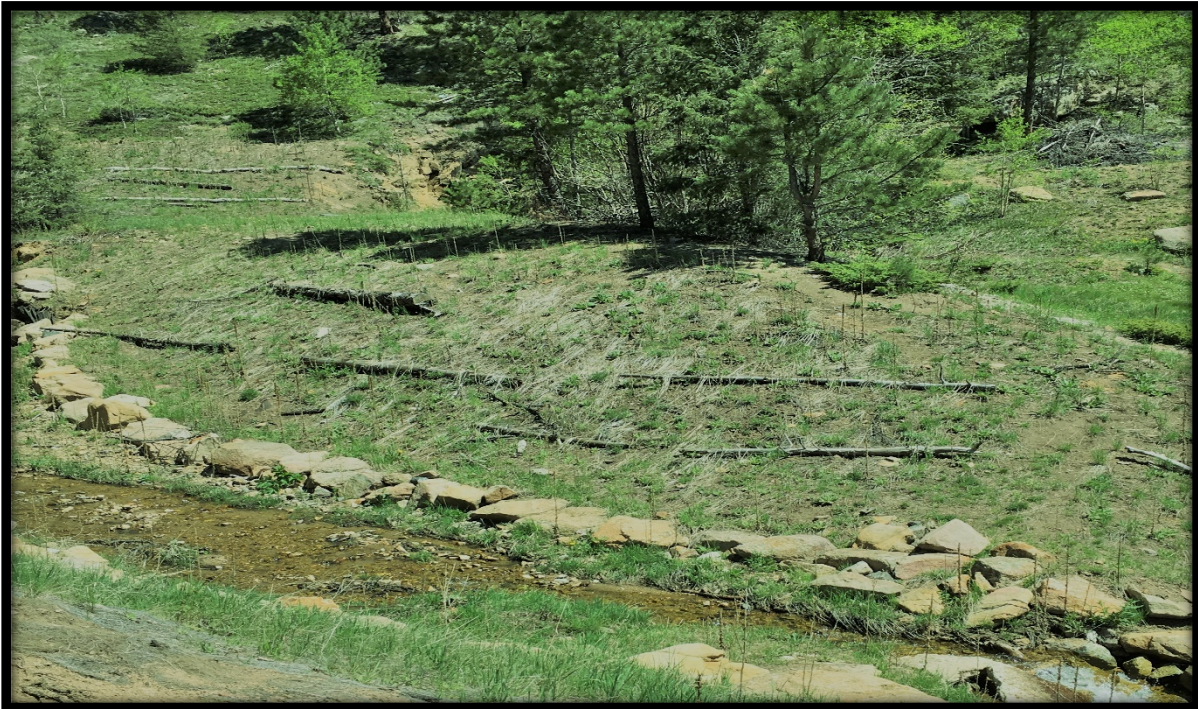
Photos #9 and #10- Reclaimed Cut Bank Slopes-Upper Repository is at the Top Left of the Photos

Concurrent with excavation and consolidation of the waste rock, topsoil was harvested from the borrow area and moved by skid steer to the upland repository. A one foot layer of topsoil was used to cap the upland repository as well as the cut bank slopes. All disturbed areas were seeded and mulched with straw. Biodegradable erosion control mat, straw wattles and previously harvested trees were placed on the reclaimed slopes and upland repository to minimize erosion.

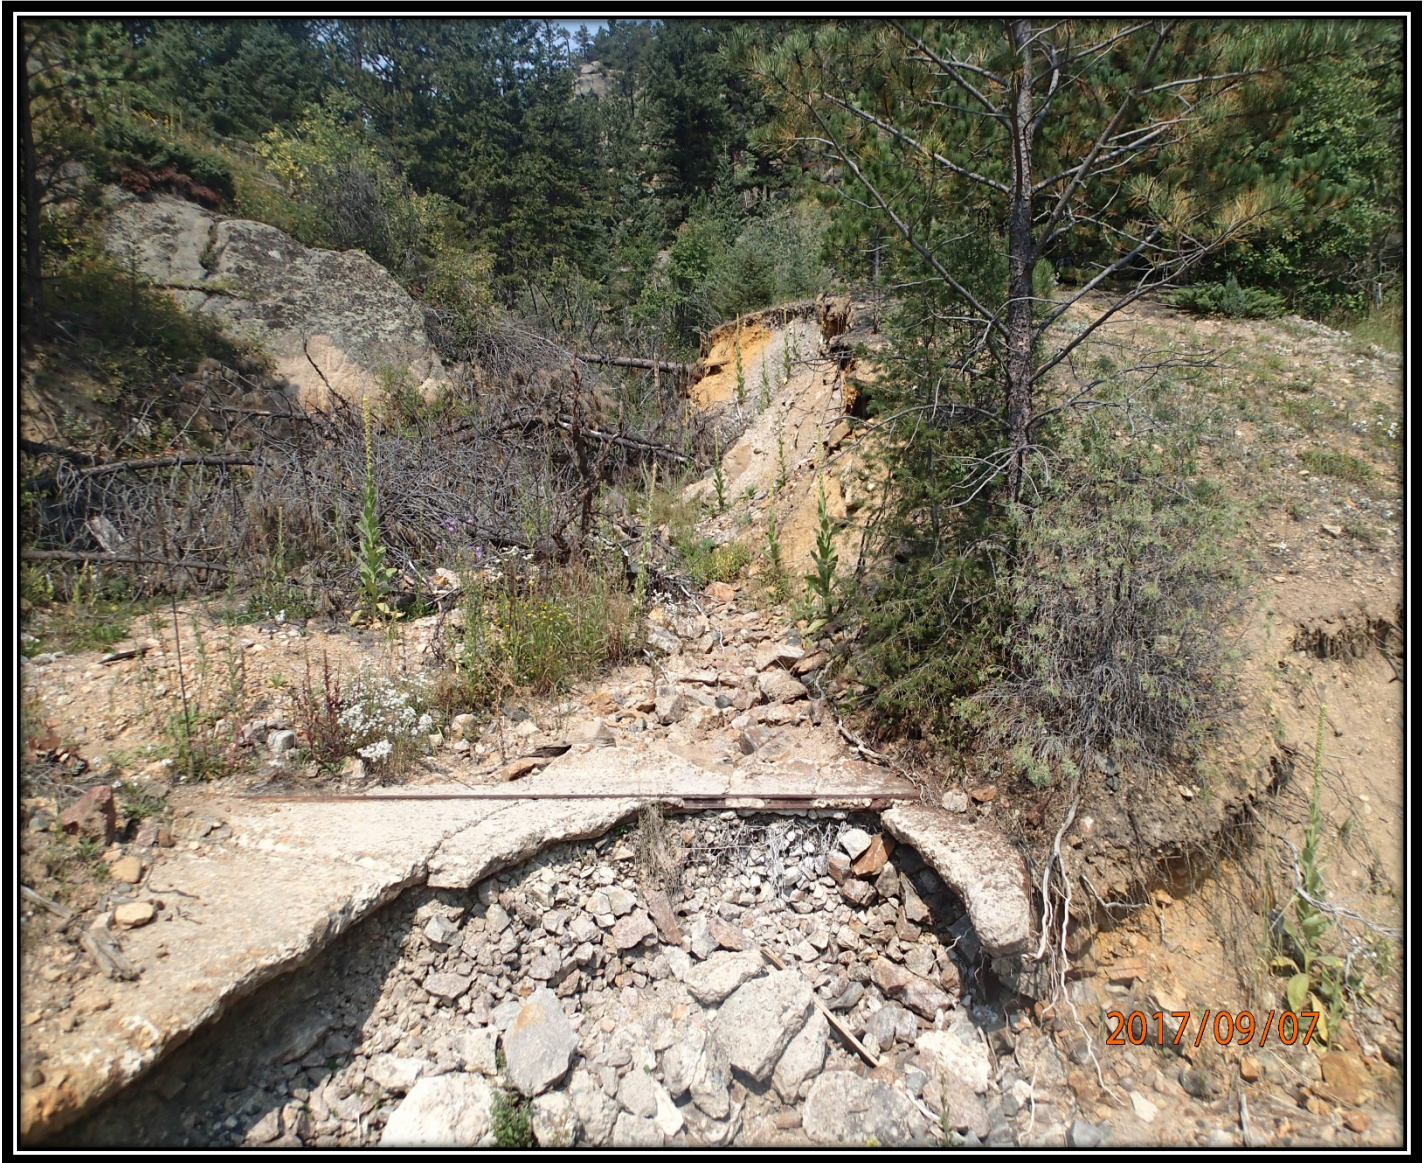
*Photo #11- Exposed Waste Rock and Tailings on Cut Bank Slope
Pre-Reclamation*

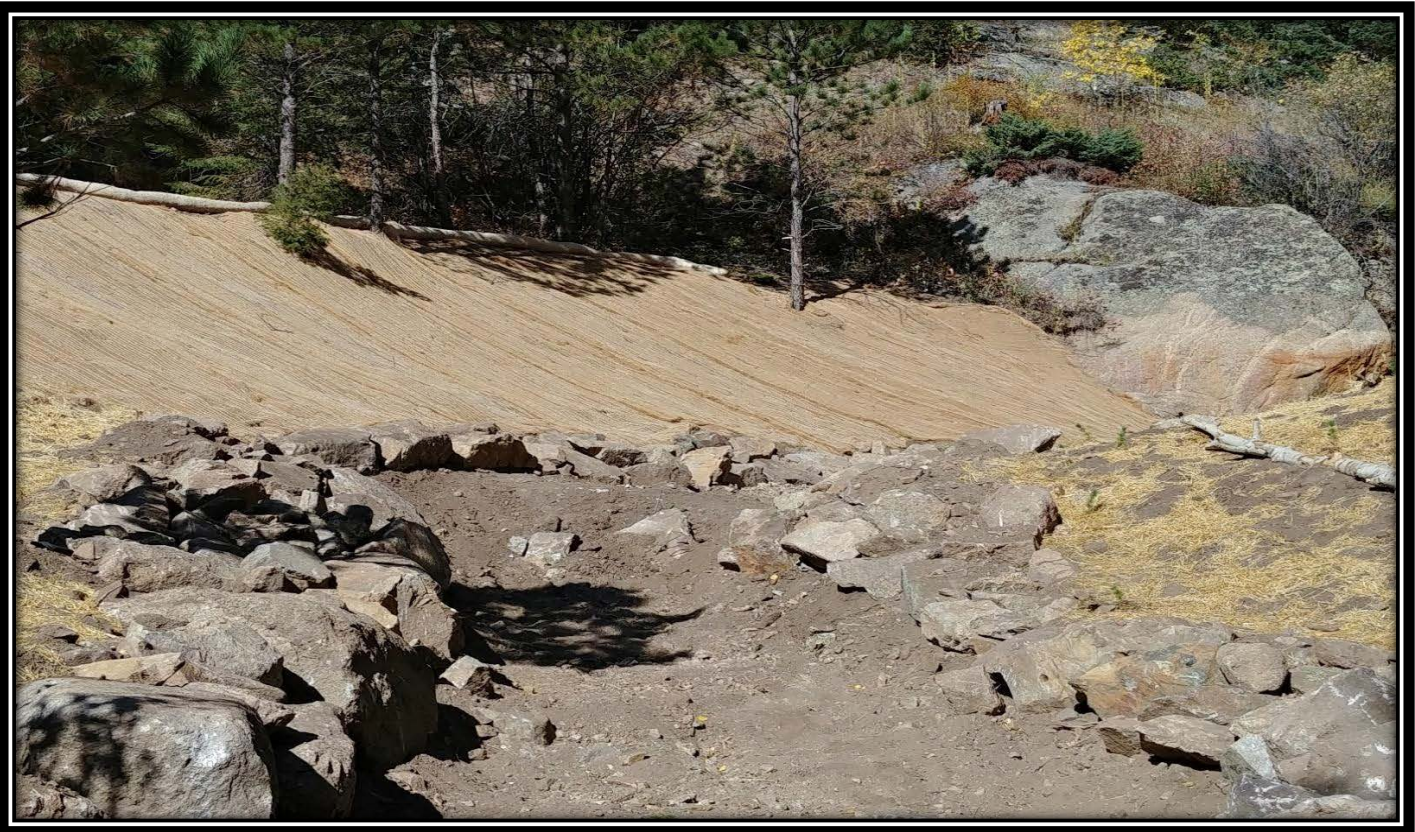
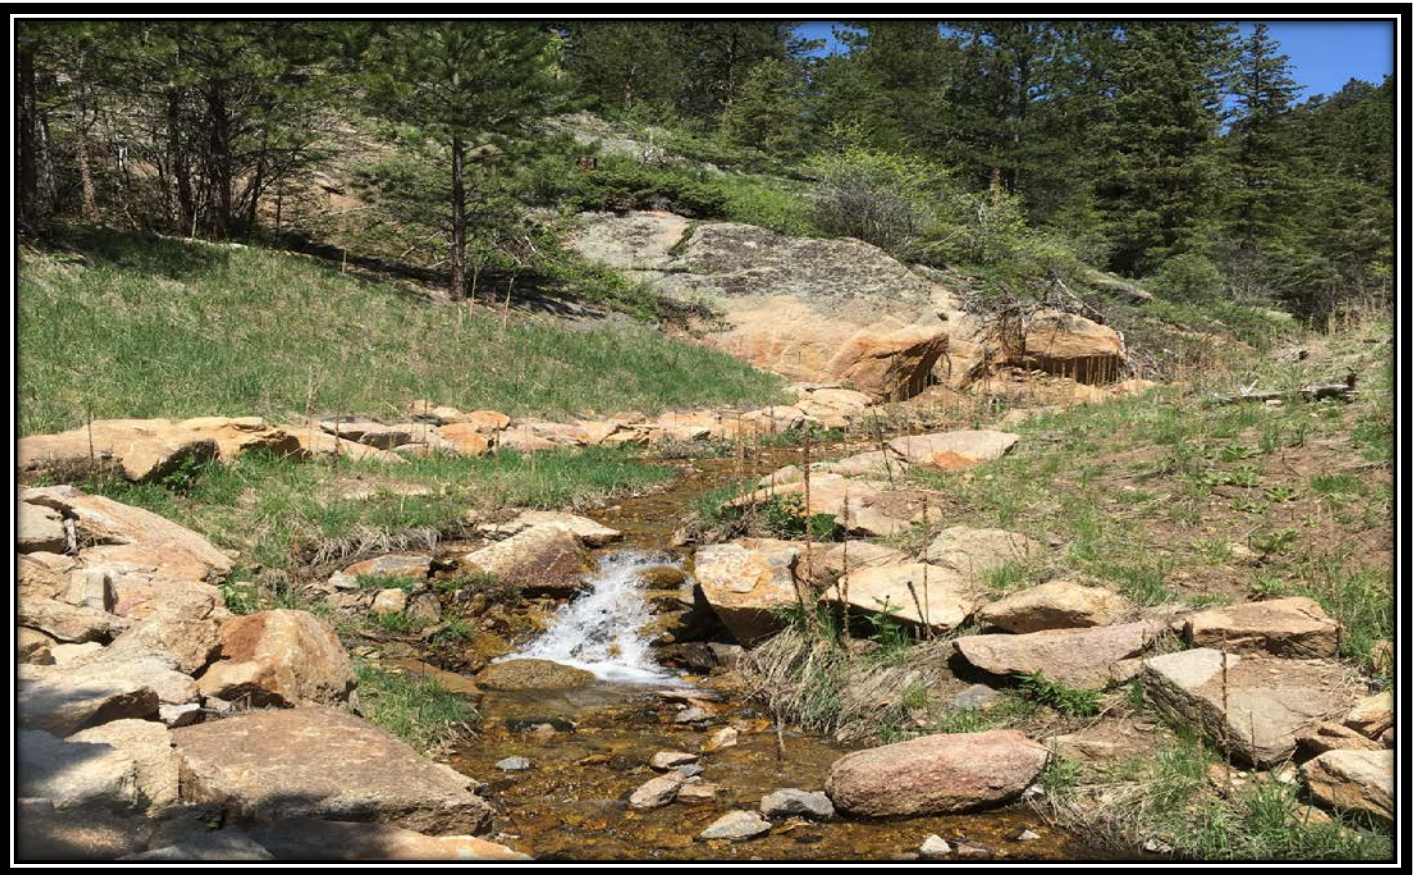
Photos #12 and #13 - Reclaimed Cut Bank Slopes

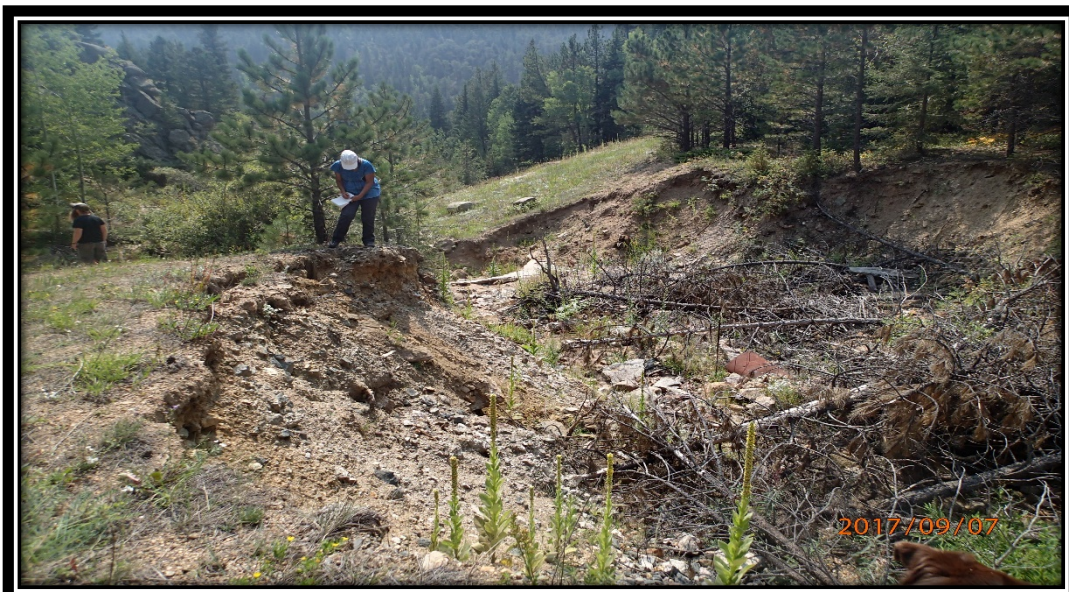
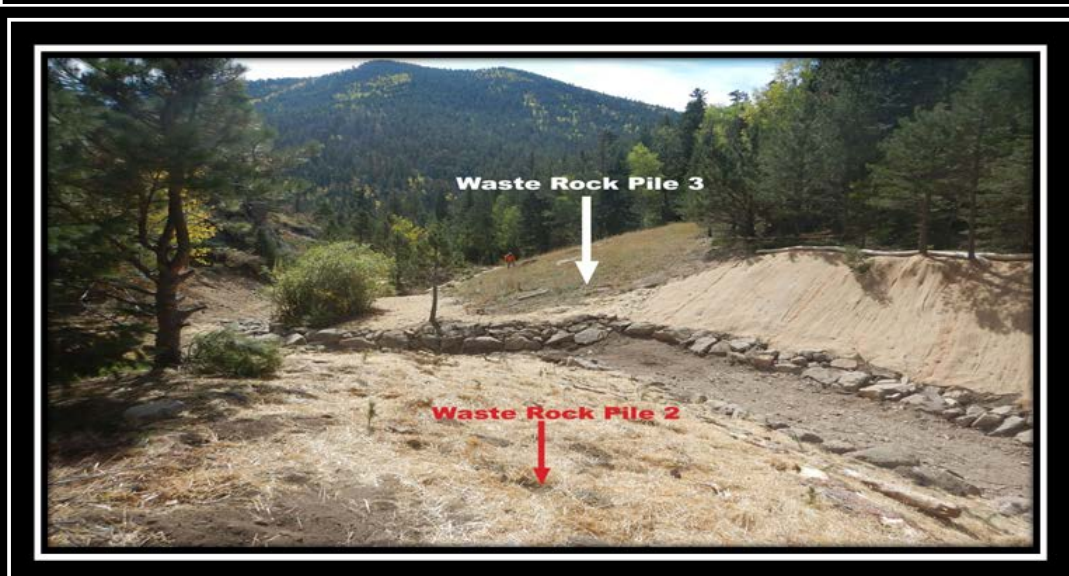
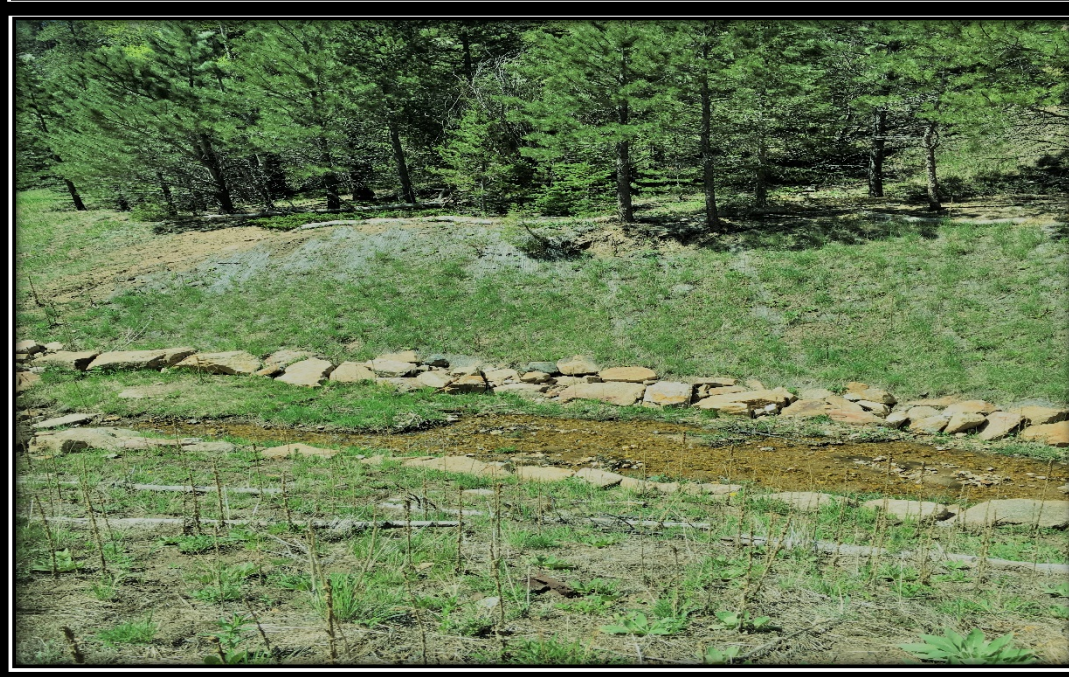
Photos #14, #15 and #16- Cut Bank Slopes and Repository Pre and Post-Reclamation Looking Downstream

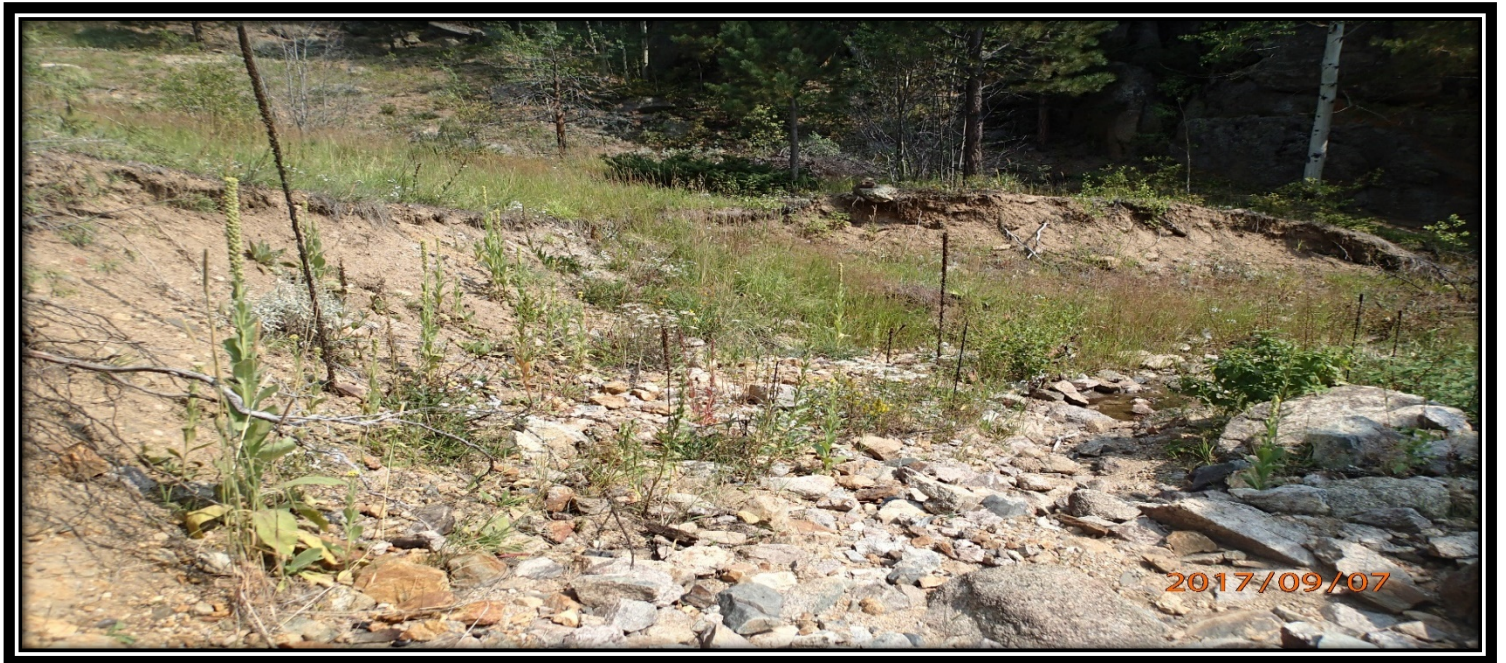
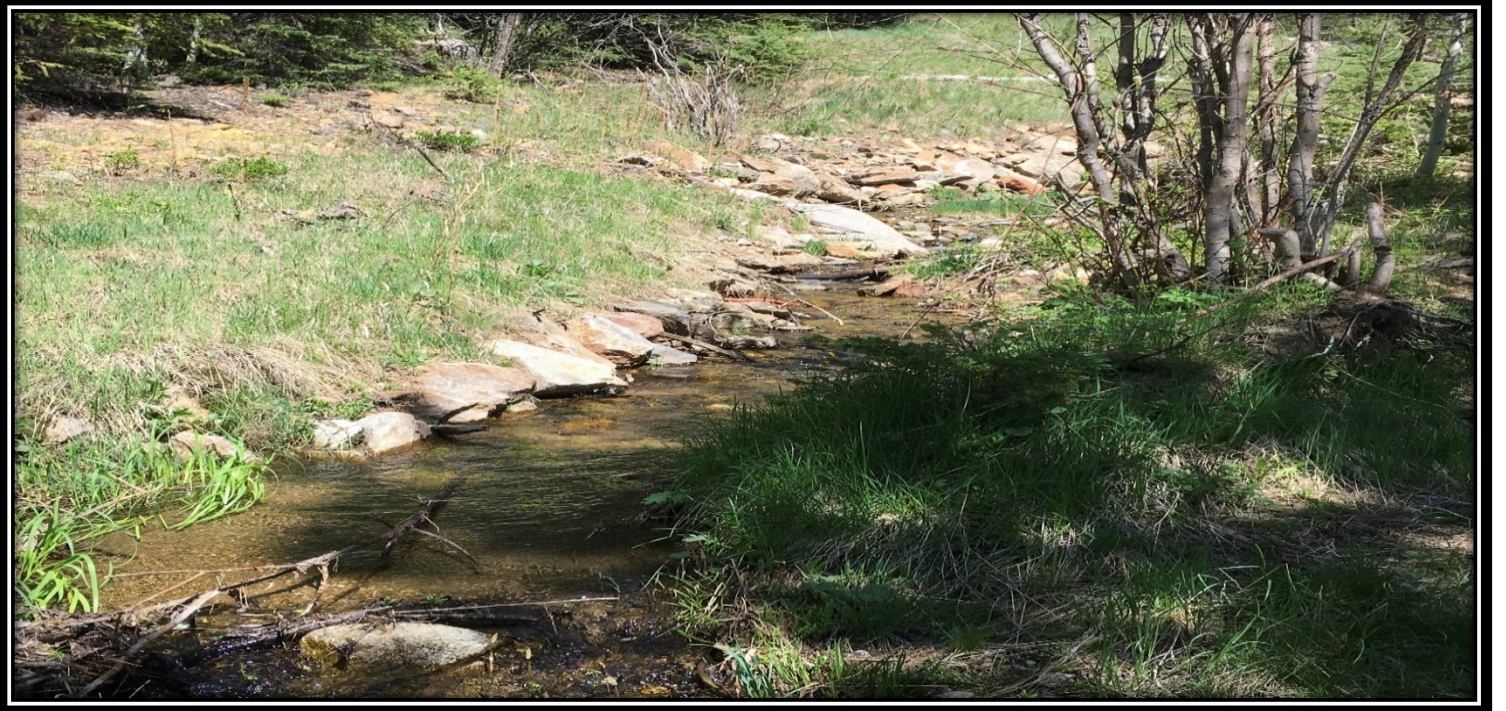
Photos # 17 and #18 - Toe of Existing Repository -Pre and Post-Reclamation

Following reclamation of the cut bank slopes, the exposed waste rock and tailings on the side slopes of the original repository were graded, covered with one foot of topsoil and then armored with rip rap. This process was time consuming and difficult because the repository was adjacent to an active stream channel. Also, the flood reduced the thalweg of portions of the tributary by over 18 feet, leaving the repository sides almost vertical. Originally, the reclamation plan included moving the channel away from the toe of the repository to achieve a 2H:1V slope gradient on the side of the repository abutting the tributary. However, initial excavation of the new channel exposed additional mine waste, not clean material. Consequently, additional rip rap had to be installed at the toe of the repository in order to stabilize it. Care was taken to reconstruct the stream channel so that the repository was protected while assuring that it conformed to the natural characteristics of the channel above and below the mine. The reconstructed channel included drop structures, stilling basins and meanders to slow the flow of water through the reclaimed area. The pre-flood alignment of the channel was reestablished where possible. The additional mine waste in the area opposite the repository was reclaimed in situ with one foot of topsoil and then revegetated.

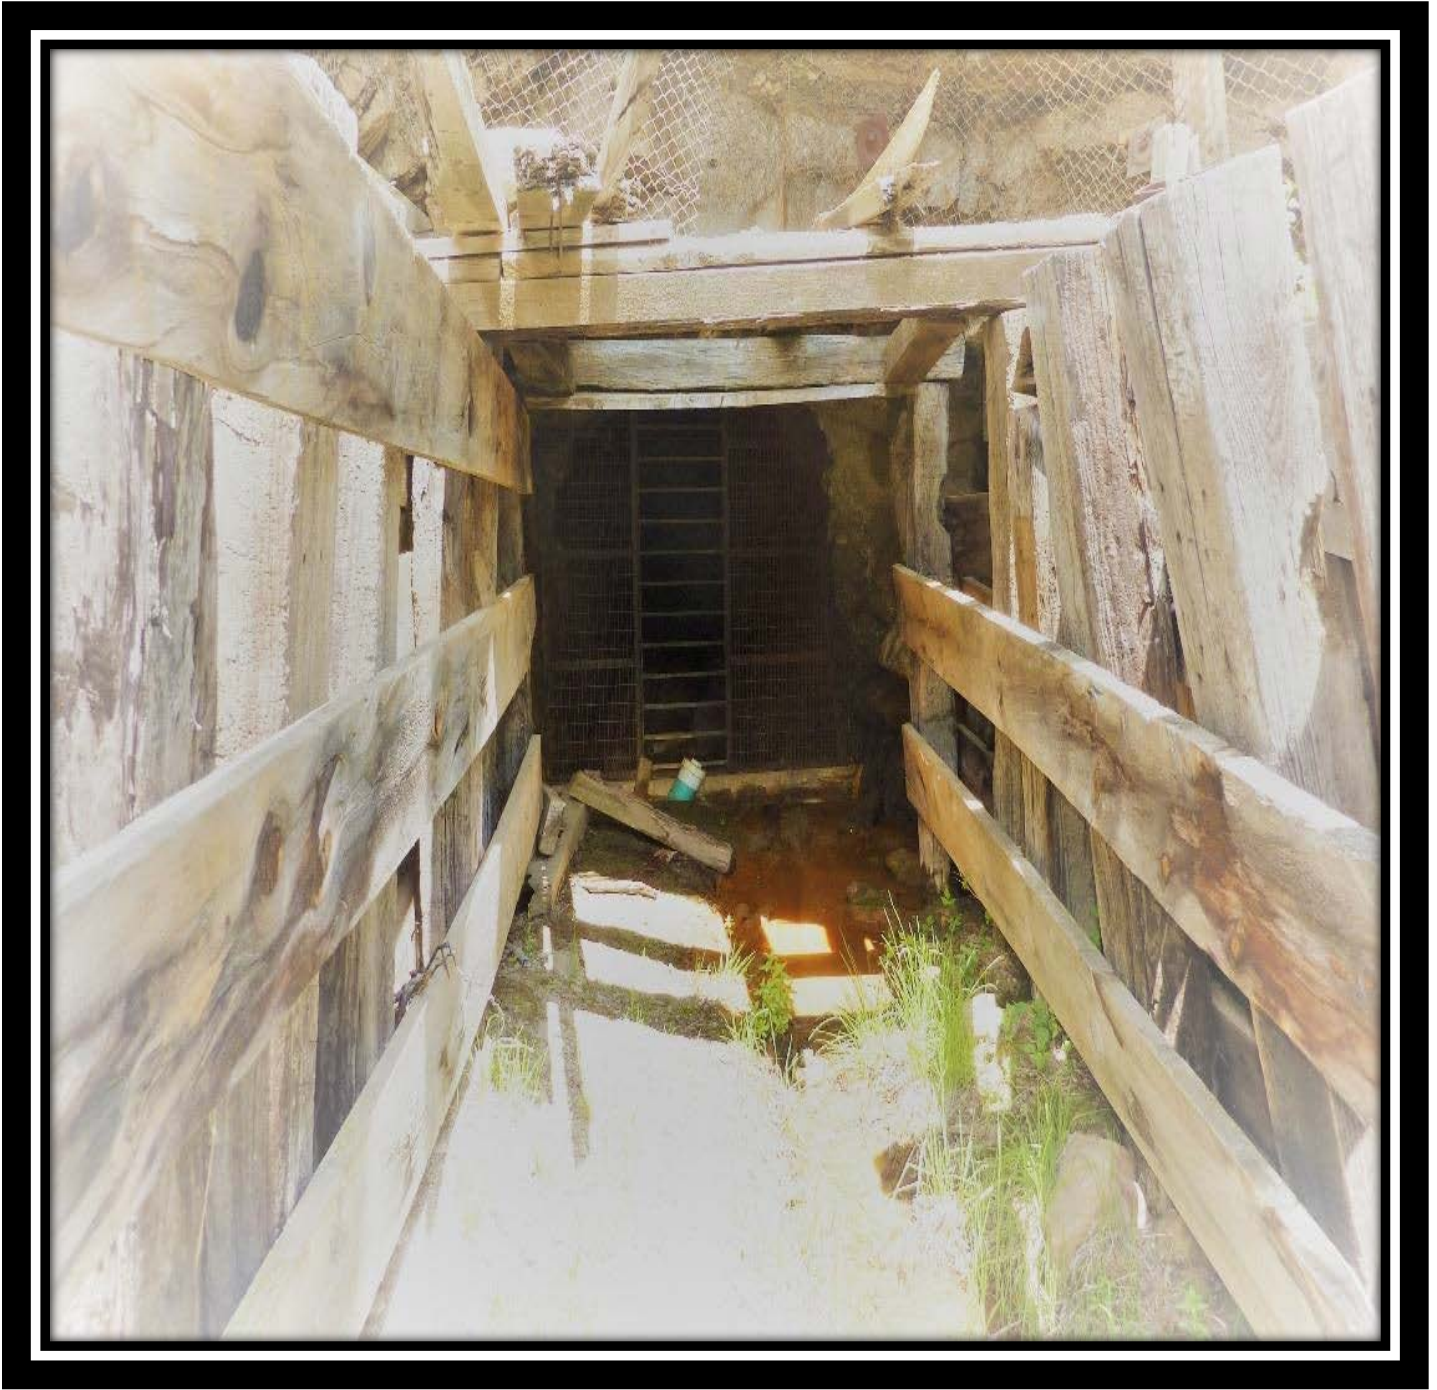
Photo #21-Mine Portal Safeguarded with Bat Grate

The adit was previously safeguarded with a bat grate by the Division of Reclamation, Mining and Safety (DRMS). Prior to safeguarding, the adit also received significant visitation from hikers and mountain bikers.

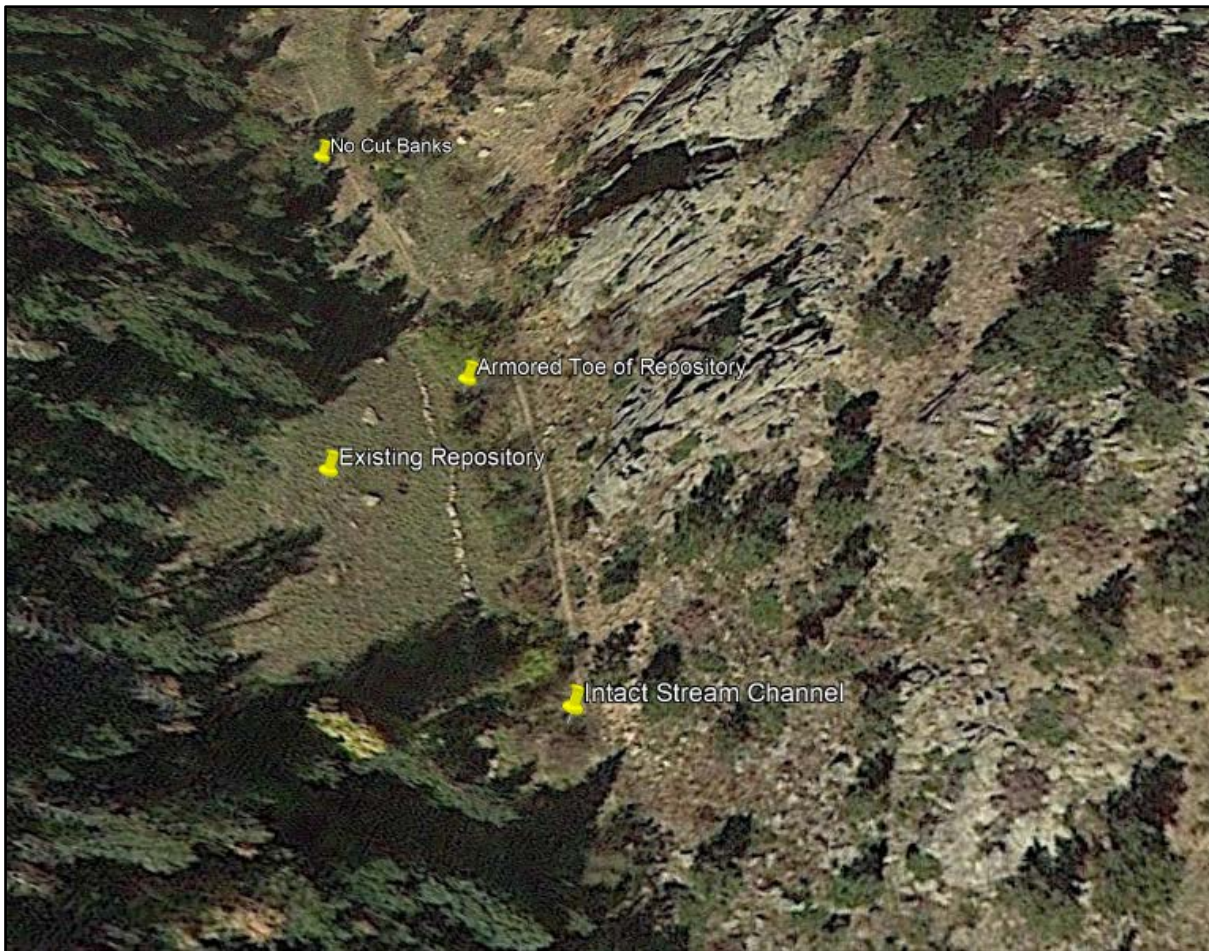
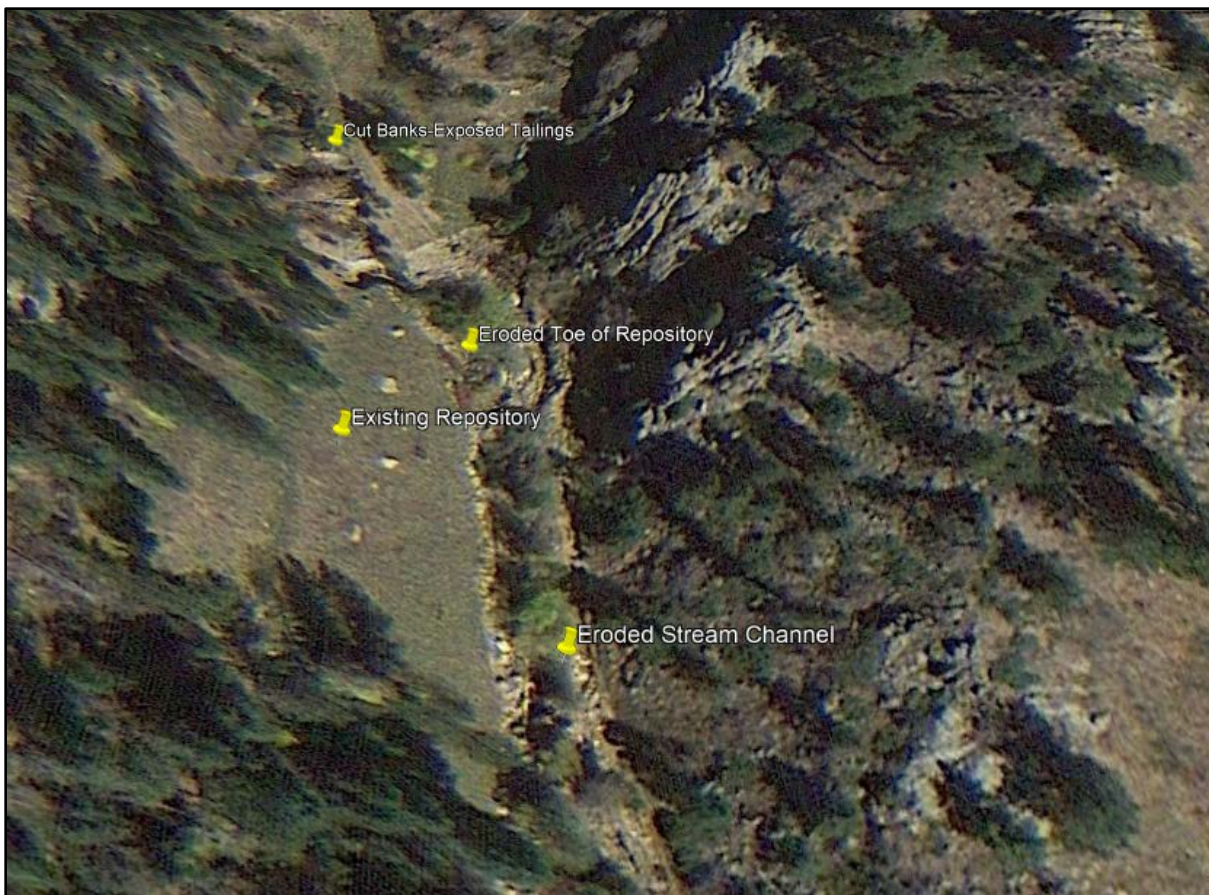
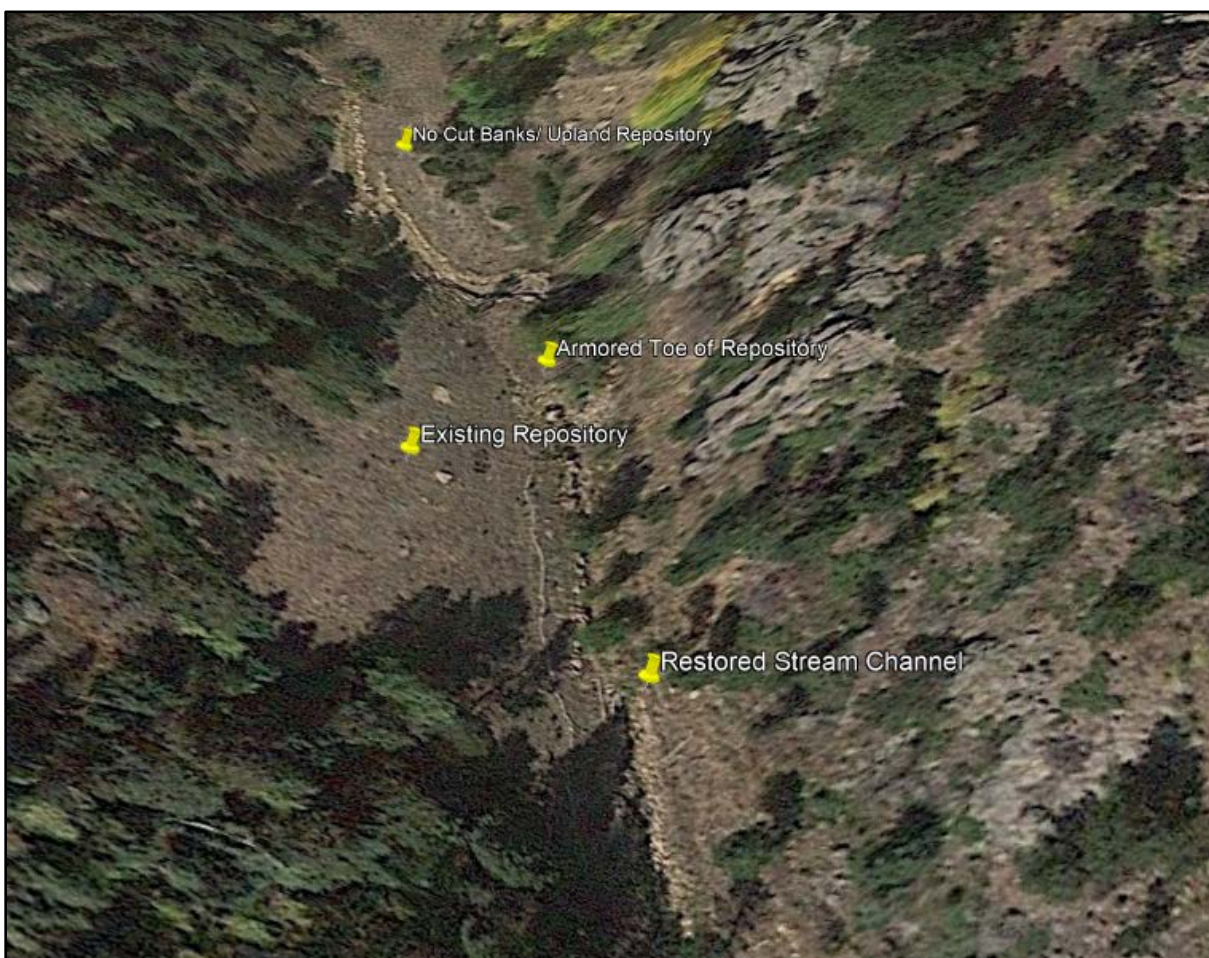
Fairday Mine Reclamation – Historic Site Images

2012 – Pre Flood

2014 – Post Flood

2021 – Post-Reclamation
