NATIONAL ASSOCIATION OF ABANDONED MINED LANDS

Nomination Category: Environmental Contamination and Physical Hazard

Project Name: Fairday Mine Reclamation Project
Project Location: Boulder County, Colorado

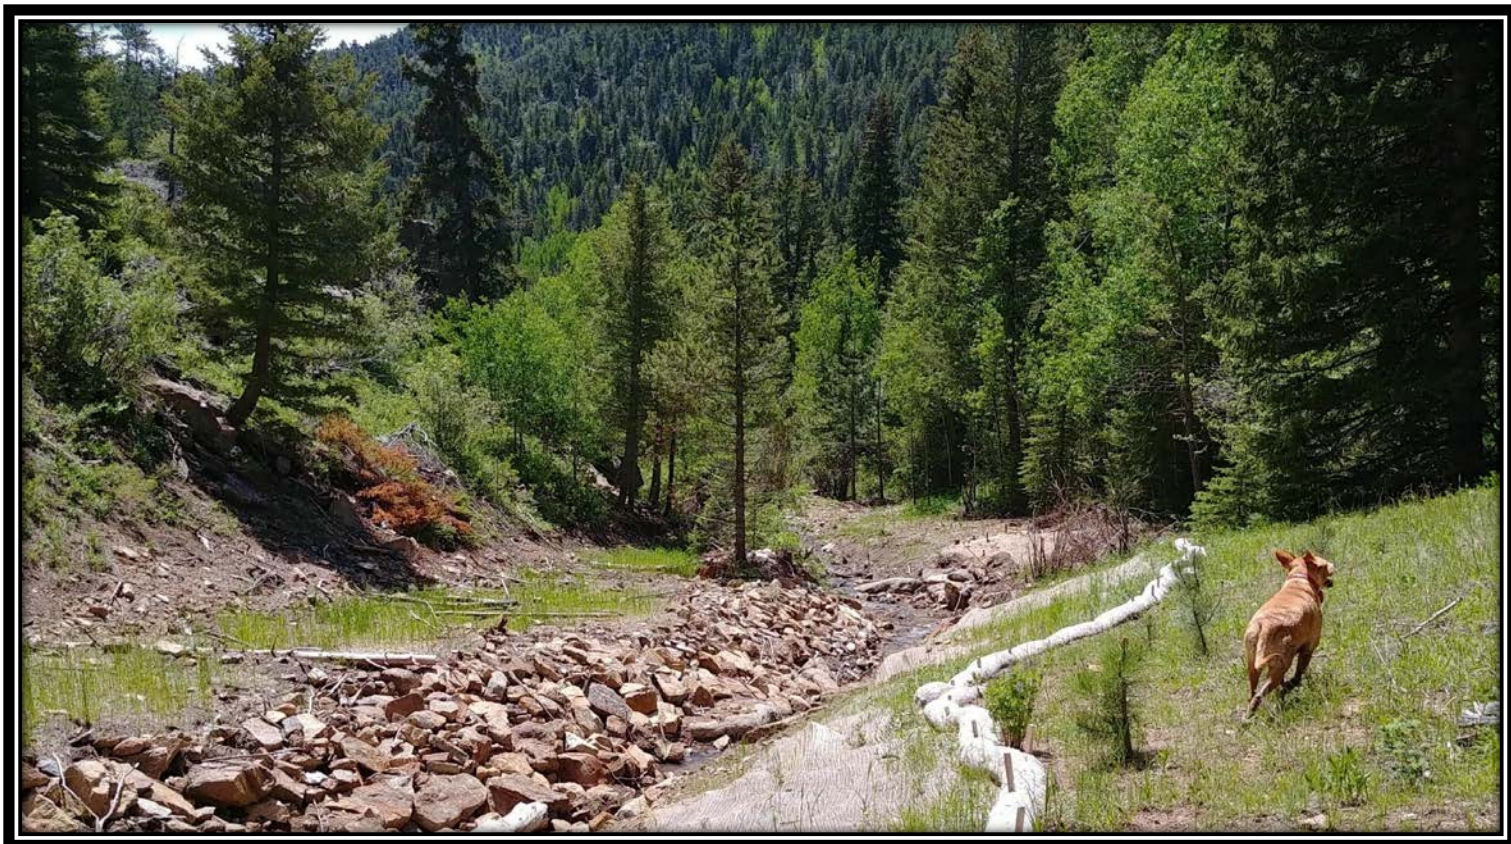
Photo #22- One Year Post Reclamation- Reclaimed and Revegetated Repository- Armored on Both Sides of Channel and Topsoil Cap

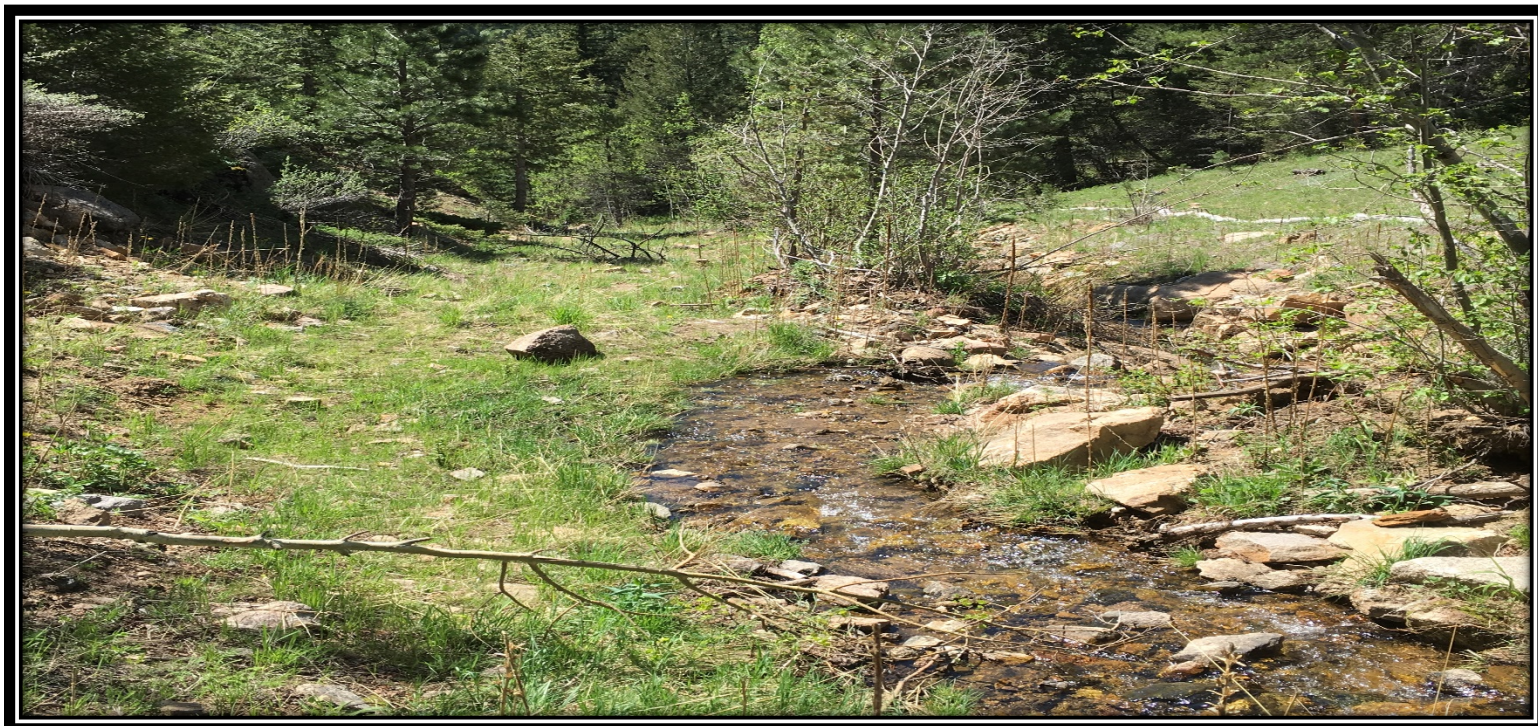
Photo #23- Two Years Post Reclamation-Left Side of Photo-Tailings that were Reclaimed In-Situ

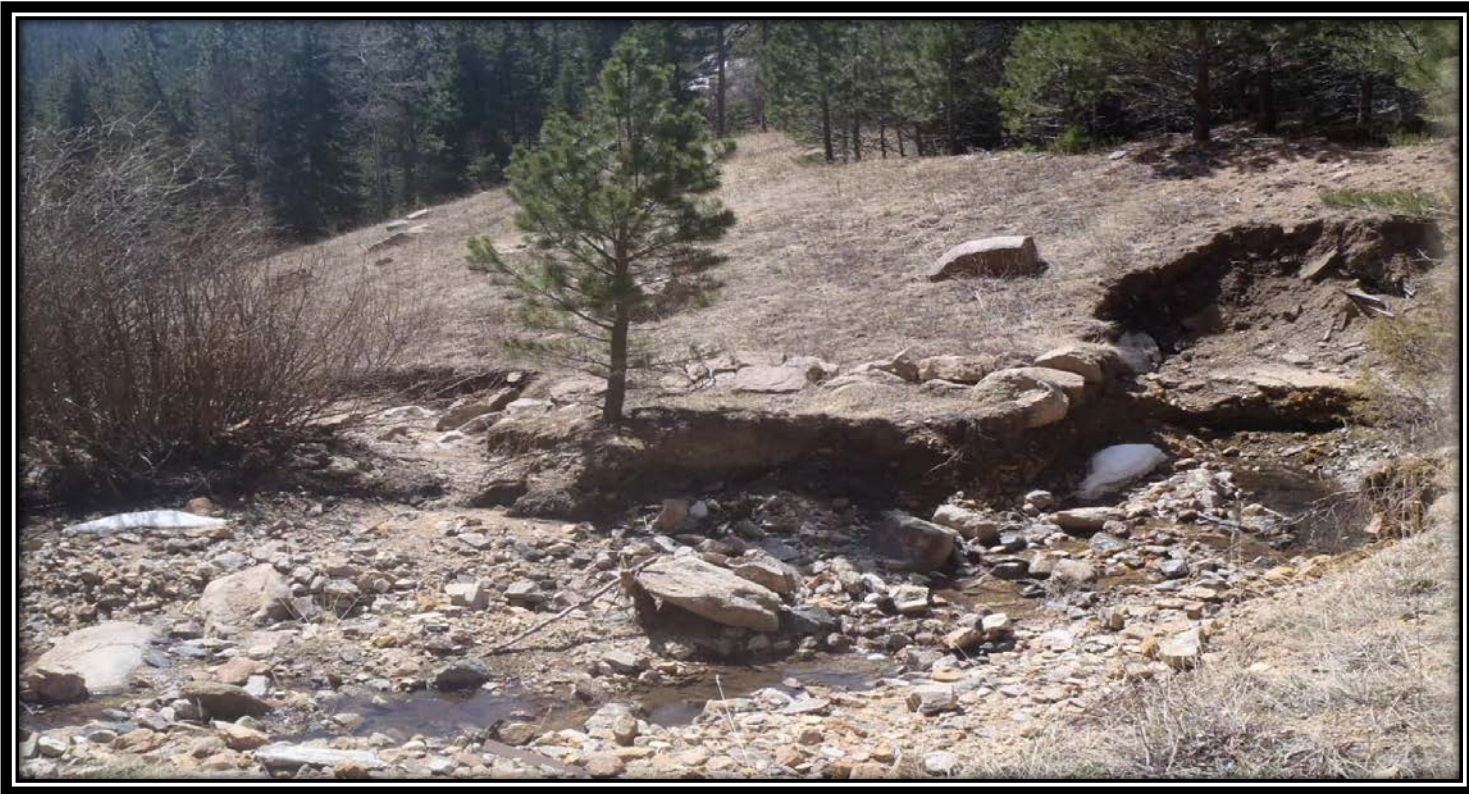
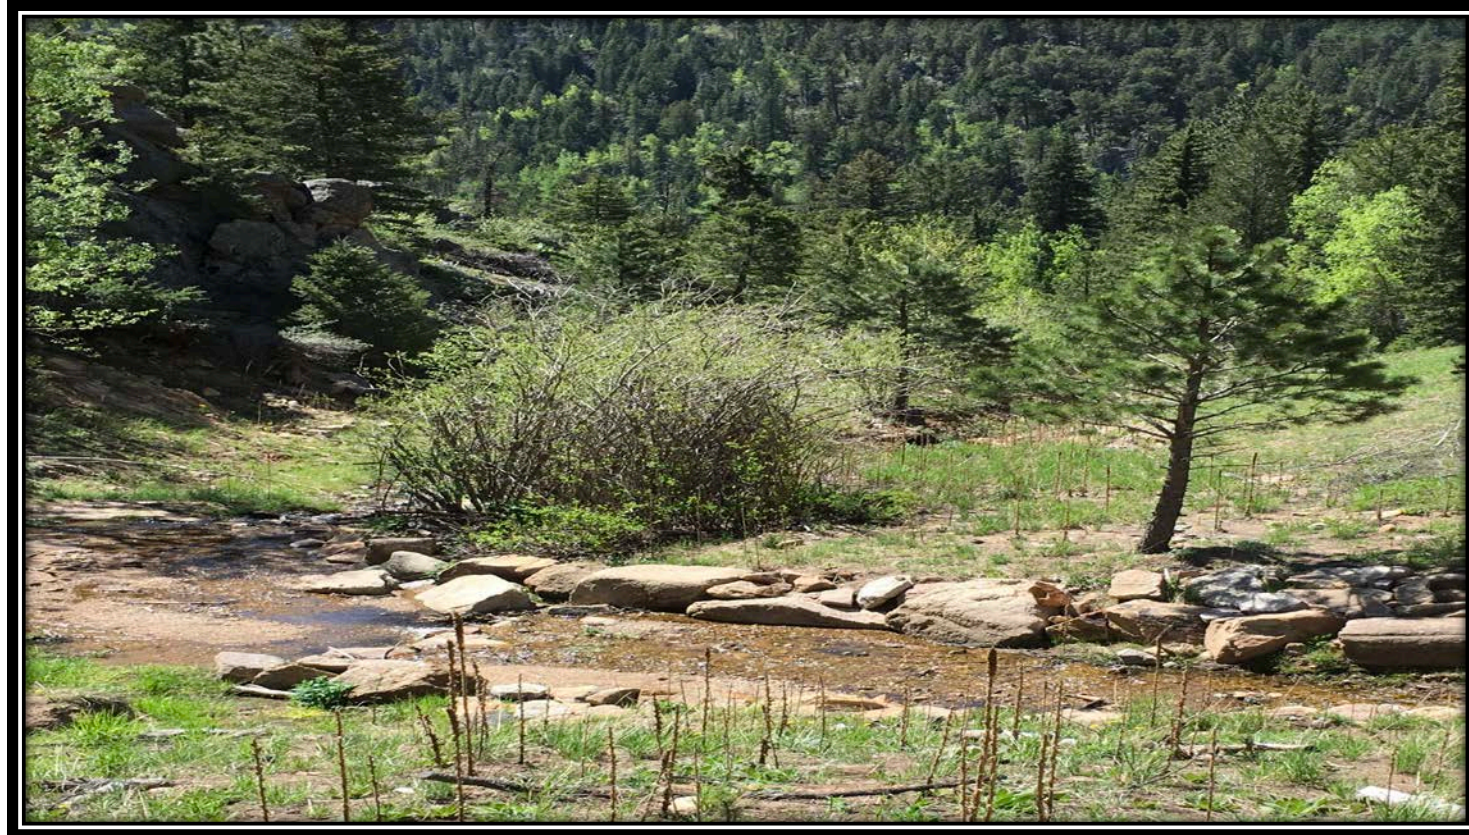
Photos #24 and #25 - Existing Repository-Pre and Post Reclamation
