2022 NAAMLPL Hard Rock Abandoned Mine Lands Reclamation Awards

Cookes Peak Mine Safeguard Project

Deming, New Mexico

Award Category:
Physical Safety Hazards

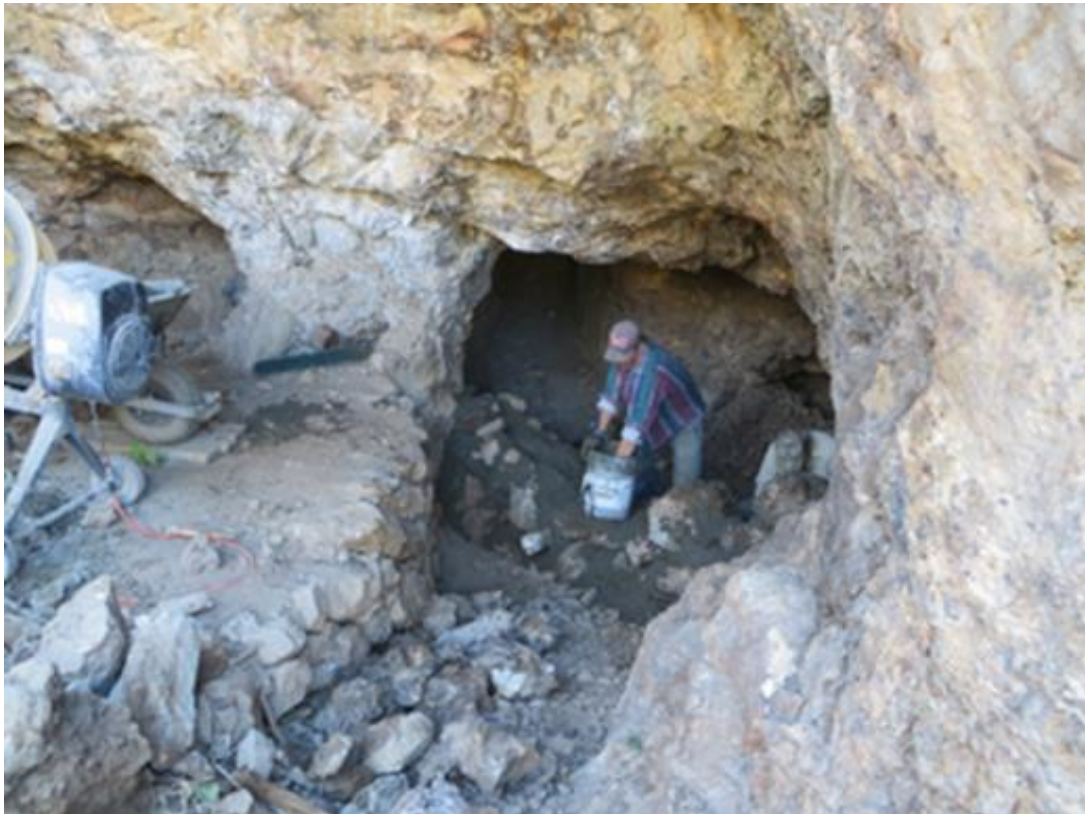
Feature 24 receiving two rock bulkheads with bat gates

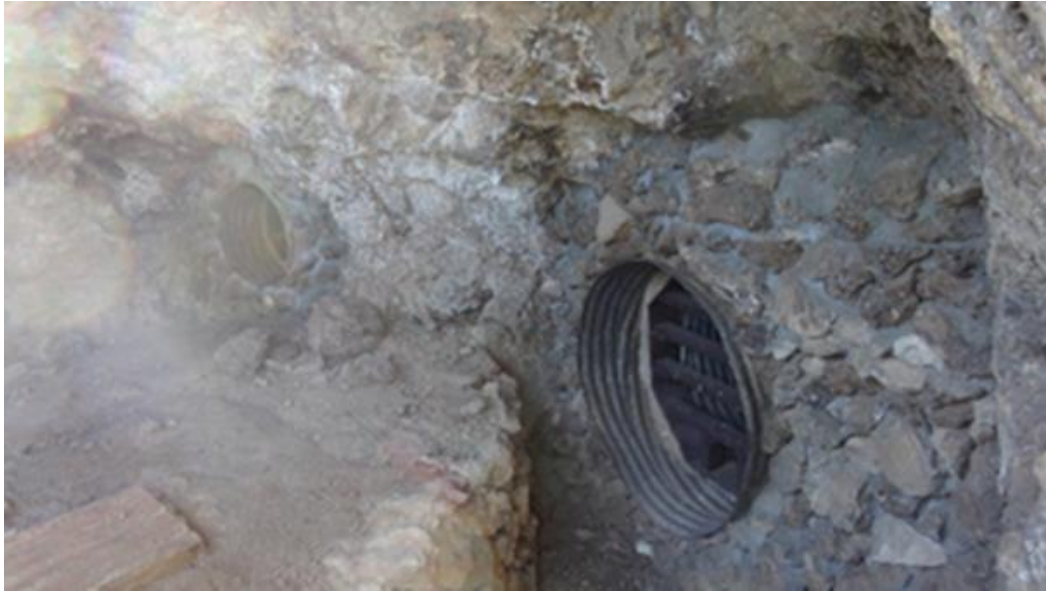
Finished condition of Feature 24

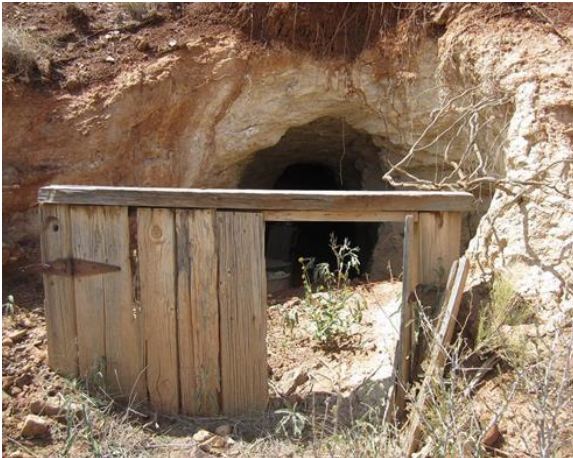
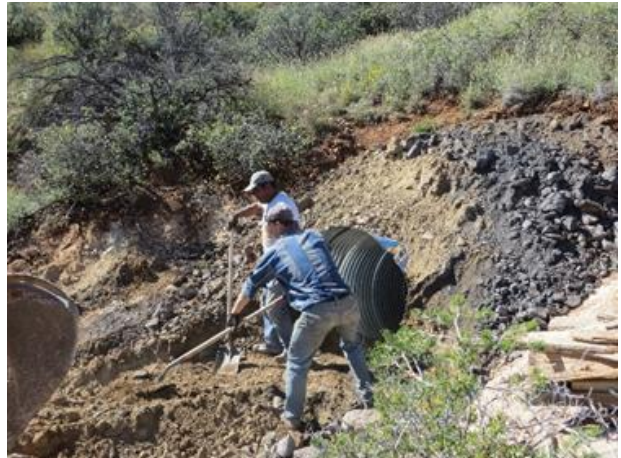
A culvert with bat gate built at Feature 39

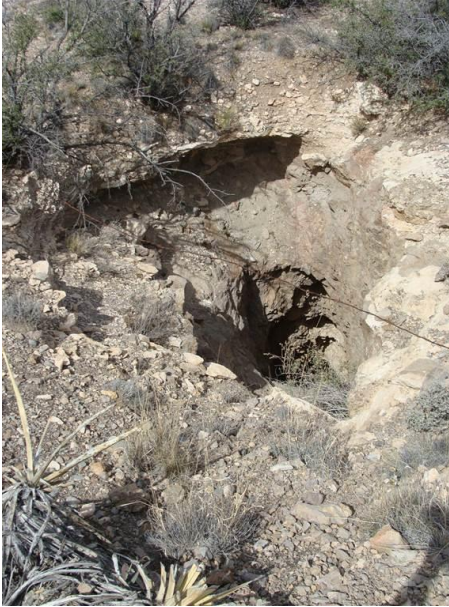
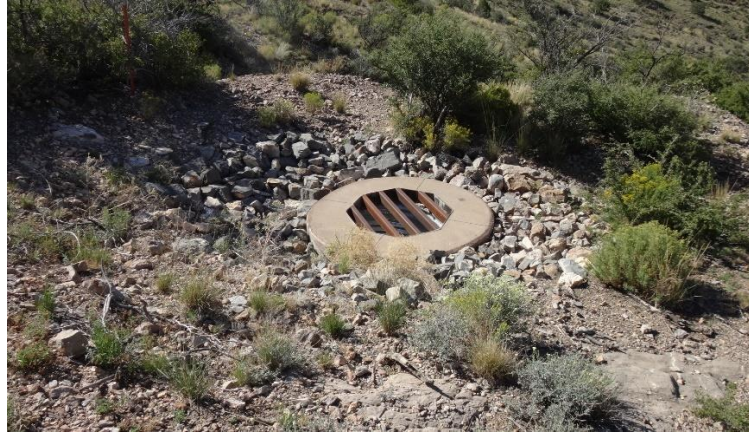
Two horizontal gates, held in place with culverts and polyurethane foam, were constructed. Feature 66 is shown here, before and after work took place.

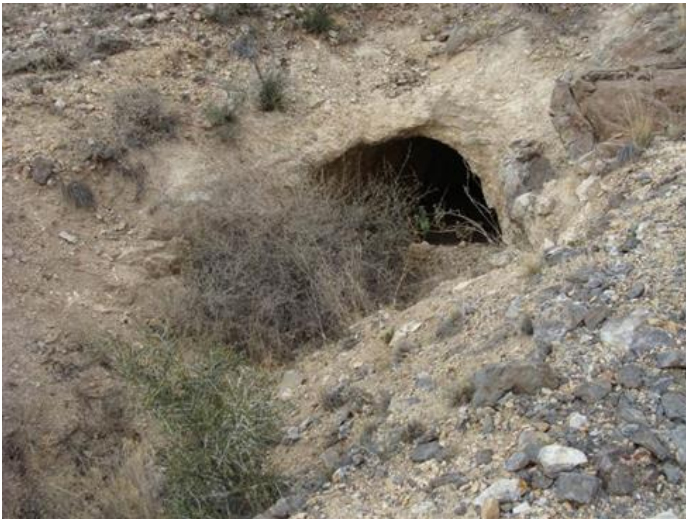
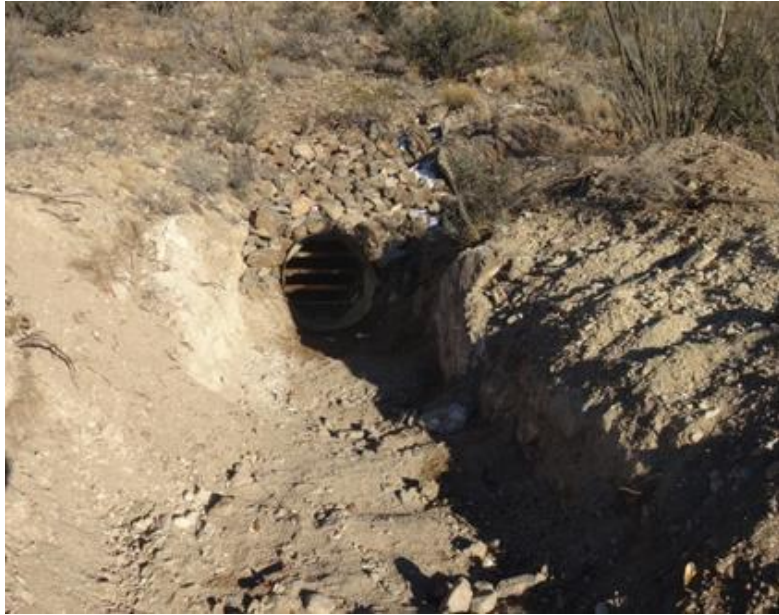
*Feature 272: 120-ft adit with a crosscut to another 10' of drift was used by *Corynorhinus townsendii* and a small species of *Myotis*.*

Finished culvert with bat gate at Feature 272.

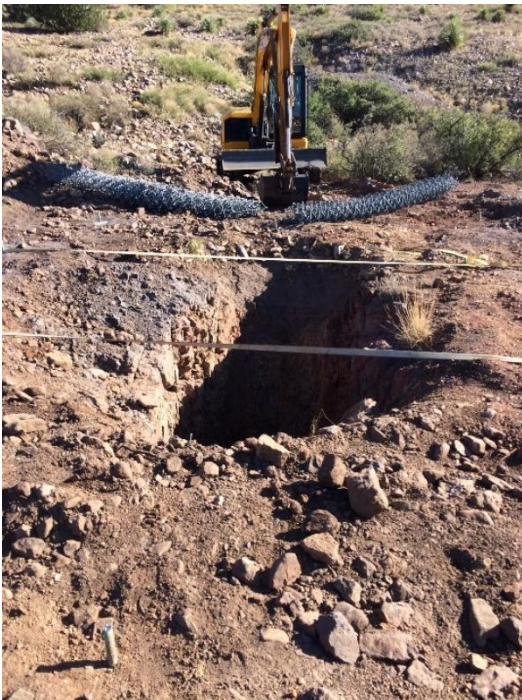
The BLM installing mesh closure at Feature 172094-6

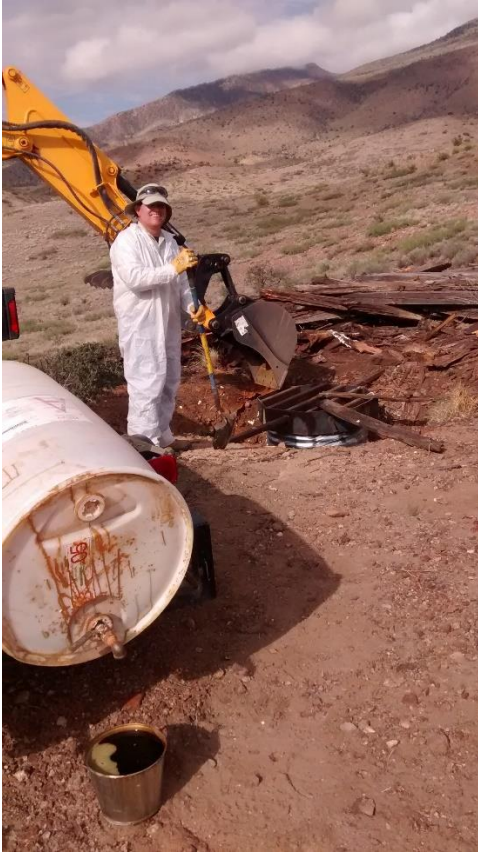
Feature 172095-24: Horizontal Bat Gate being built by the BLM at 100 ft deep shaft.

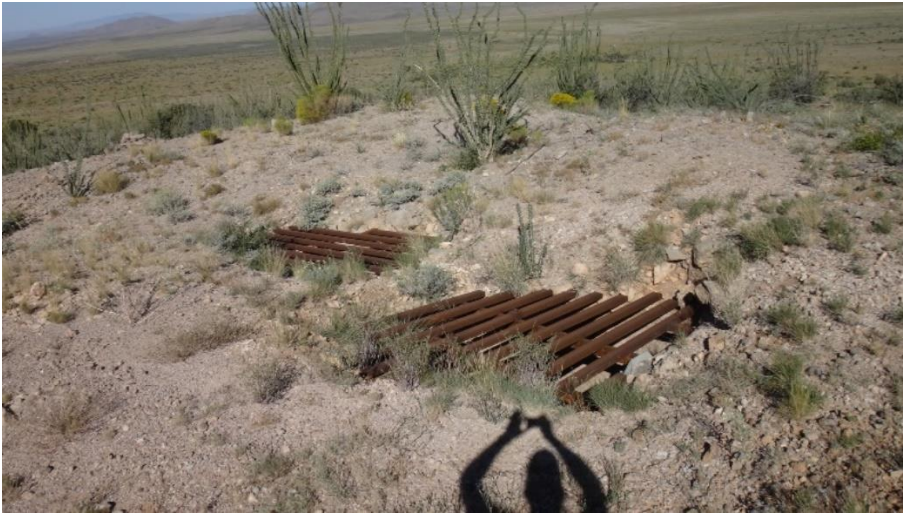
Typical horizontal bat gate that allows for owl use.

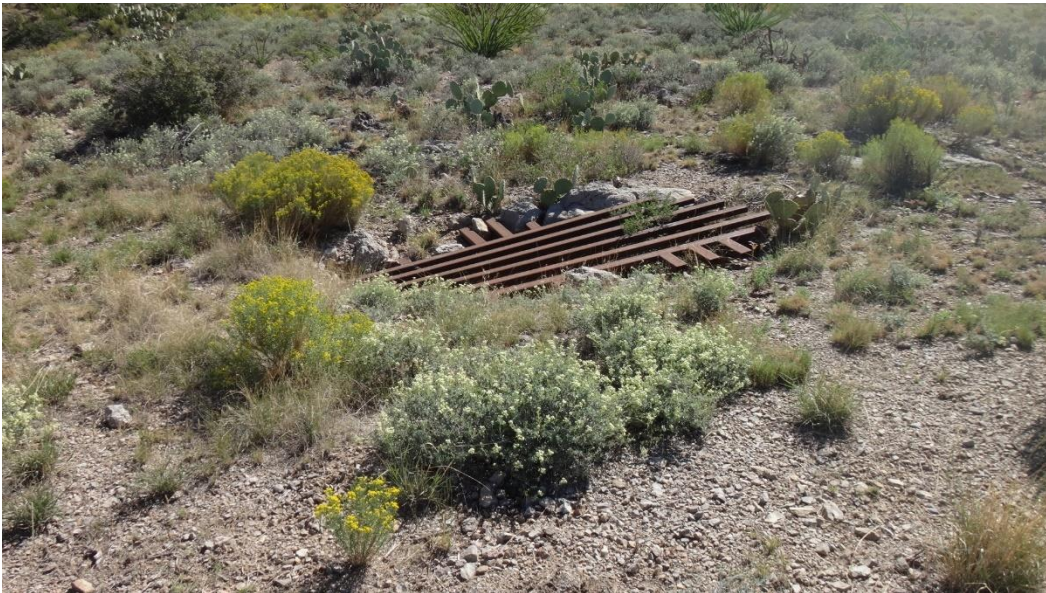
Typical horizontal bat gate that allows for owl use.

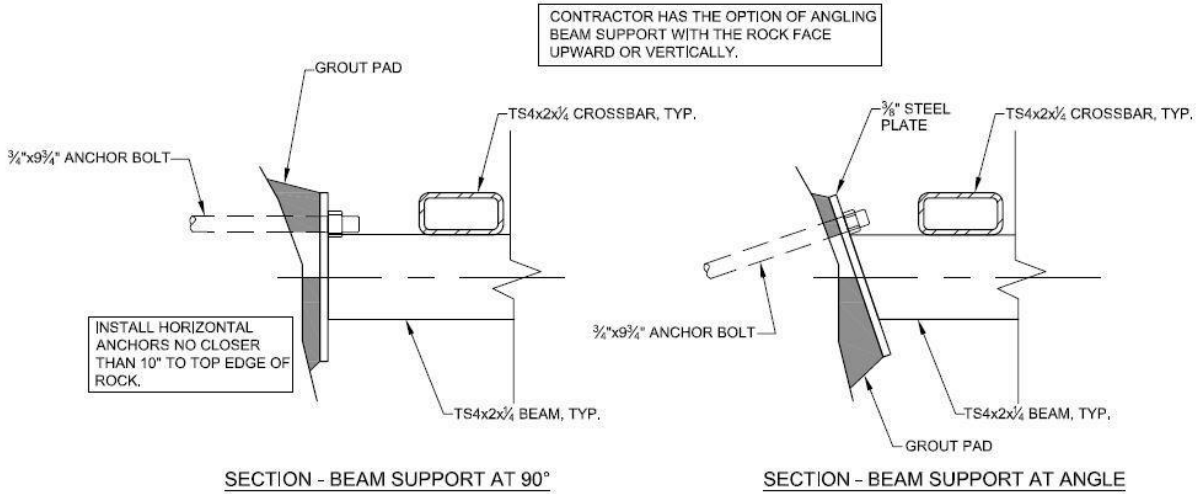
BEAM SUPPORT SIDE SECTION

SCALE: 1/2" = 1'-0"

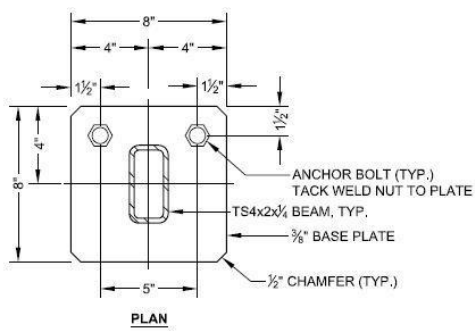
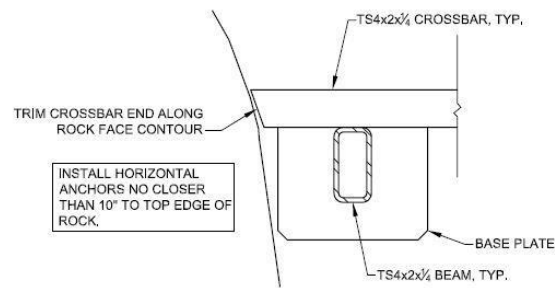
BEAM-CROSSBAR SECTION VIEW

SCALE: 3/4" = 1'-0"

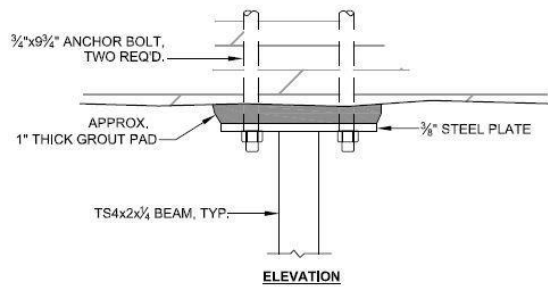
BEAM SUPPORT DETAIL

SCALE: 1/2" = 1'-0"

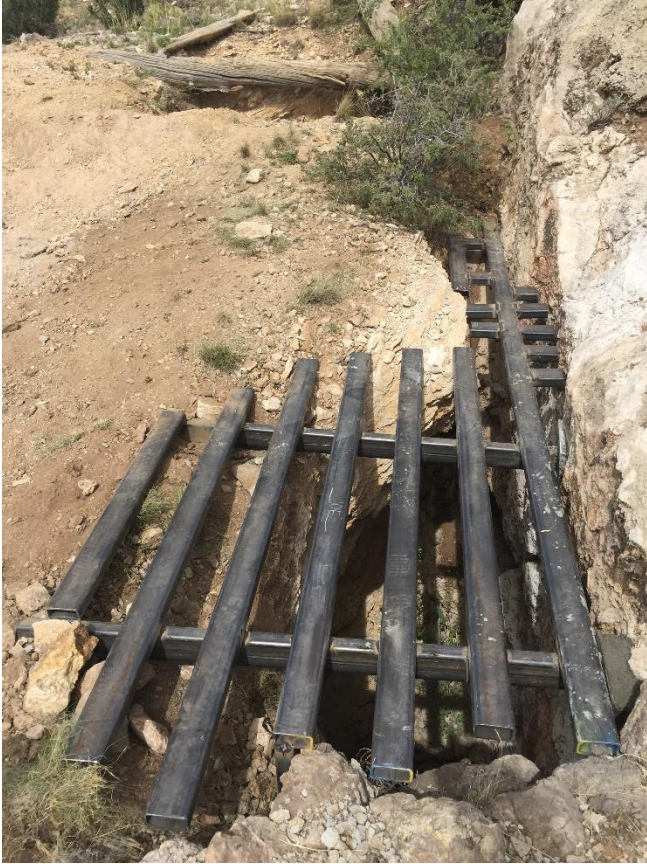
Horizontal Bat Gate at Feature 281 showing the bars cut to fit the mine opening.

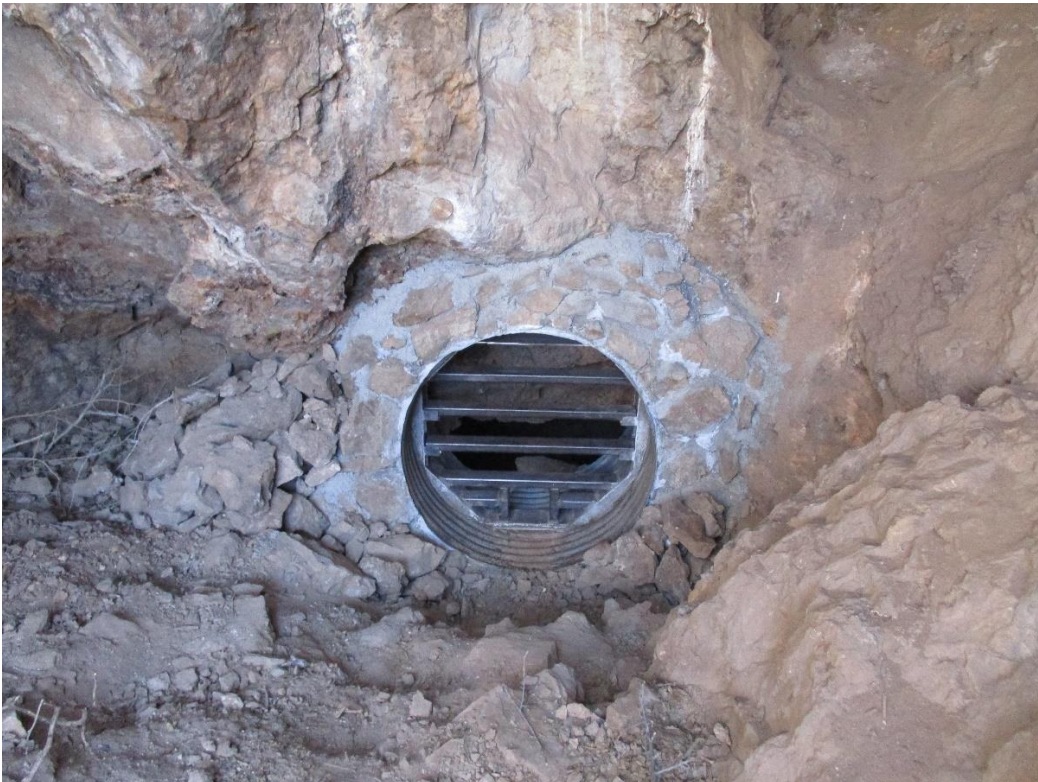
Culvert with Bat Gate installed at Feature 55.

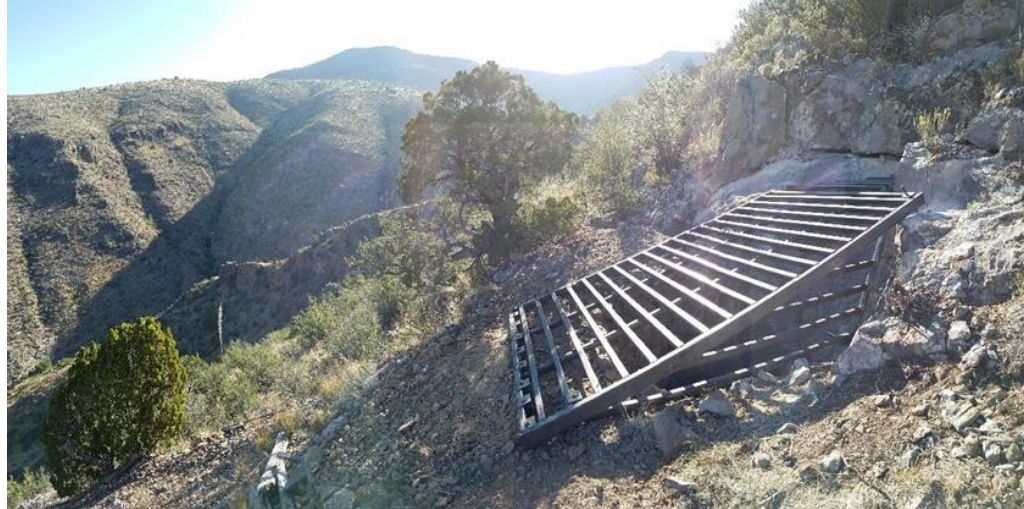
Bat Gate installed at remote location with the help of a helicopter.

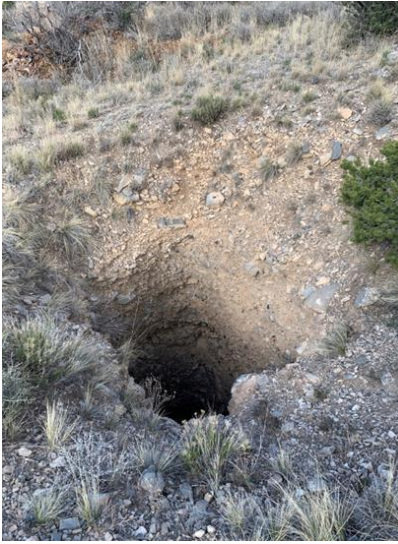
Standard horizontal bat gate installed by Hurricane Industries in a Wilderness Study Area.

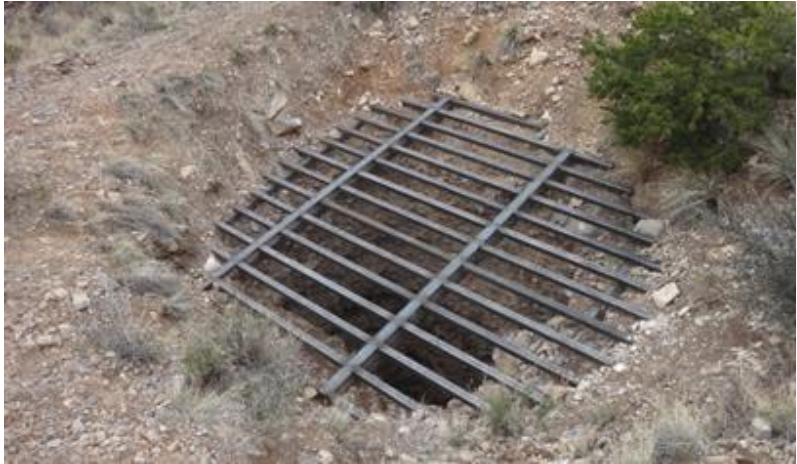
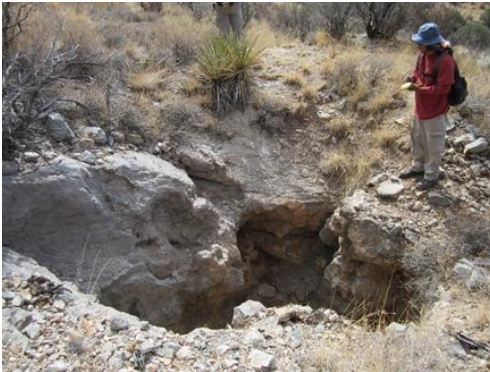
Another horizontal gate constructed in and around a Wilderness Study Area.

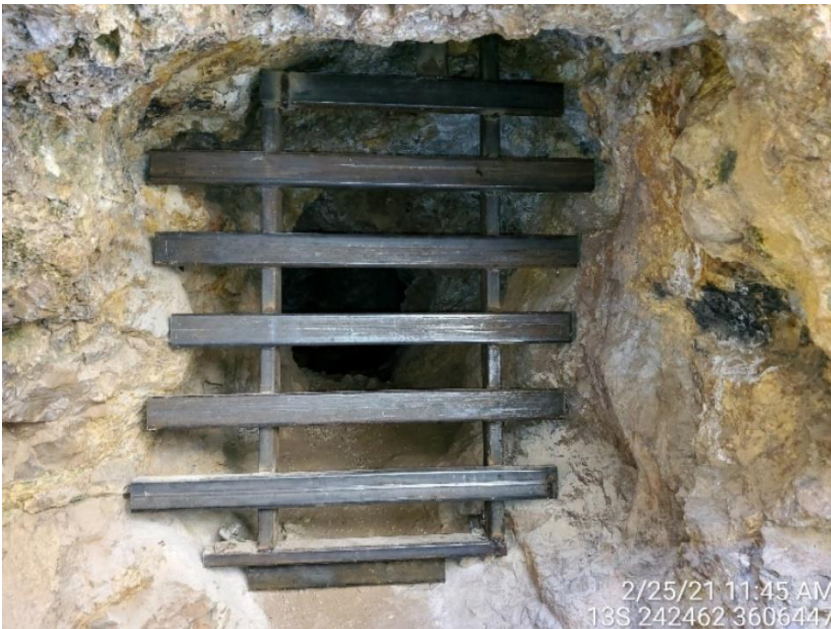
Bat Gate constructed by MineGates Environmental in a very remote location.

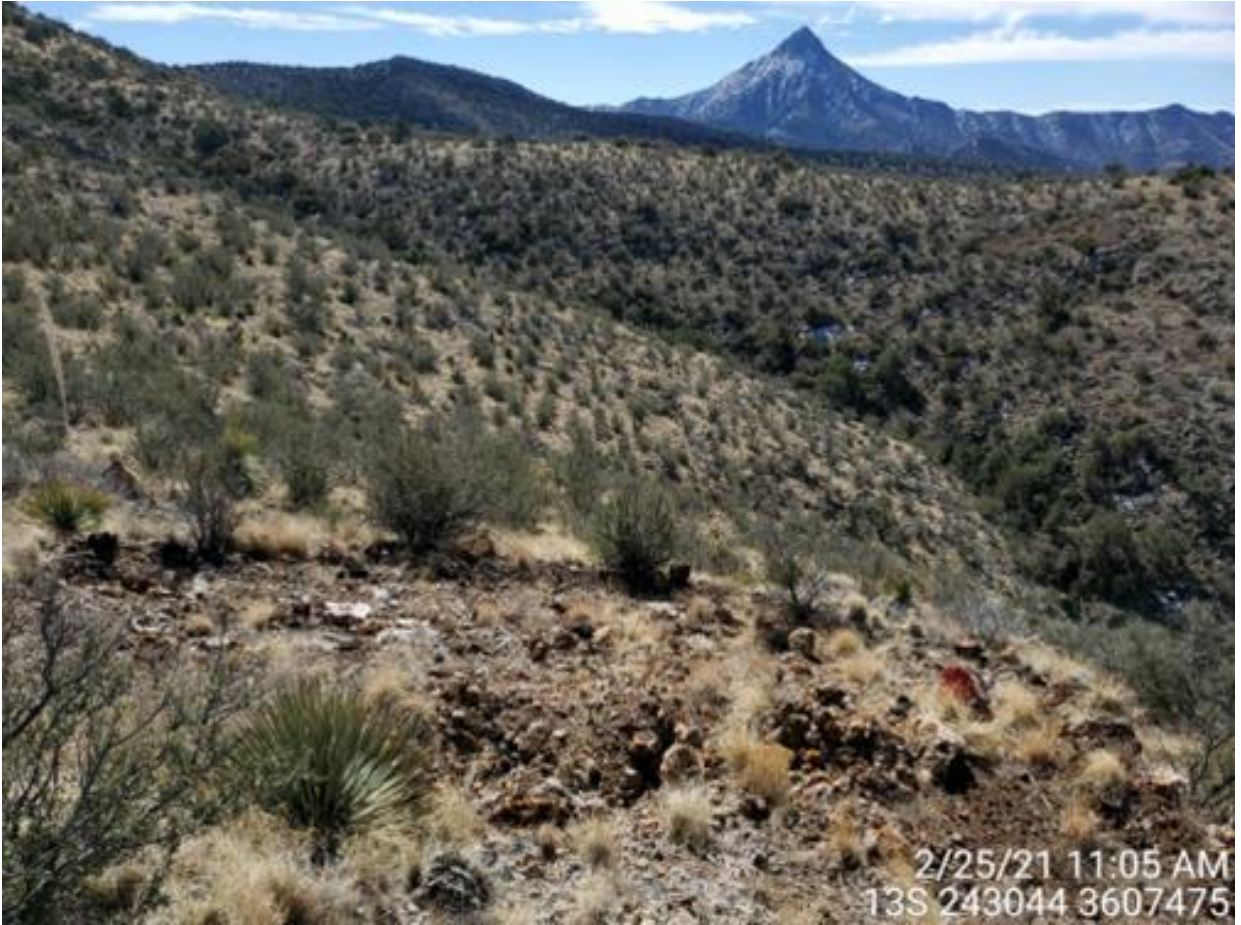
Backfilled mine shaft in remote location
